Housing Innovation Showcase 2012 Building Performance Evaluation Phase 1 – Part 1

HOUSING INNOVATION SHOWCASE 2012
affordable ^ sustainable ^ construction

kingdom
housing association

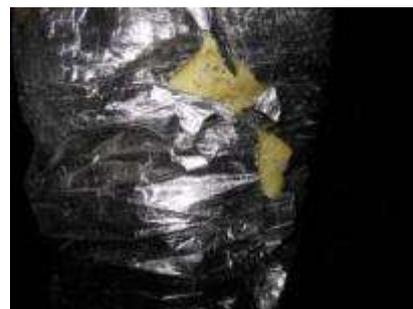
Figure E09 – Damaged insulation observed on MVHR ducting

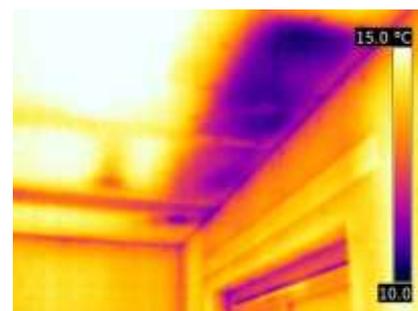
Figure F05 – IR image internal plot 17, thermogram identifying heat loss attributed to missing ceiling insulation

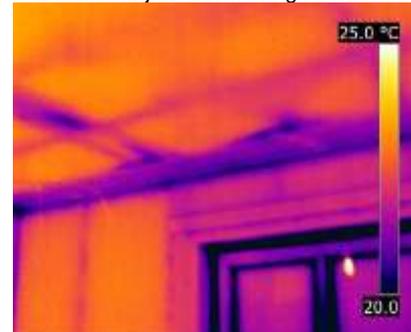
Figure F07– First floor ceiling – missing insulation bedroom plot 18

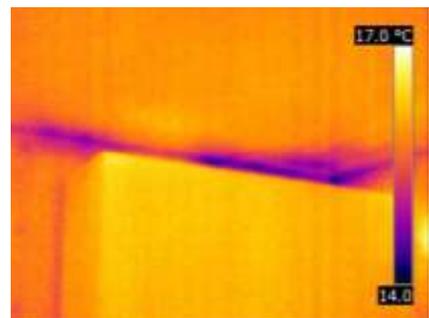
Figure G05 – IR image internal wall and ceiling junction of plot 19 in kitchen above wall cabinets showing heat loss through uncontrolled air infiltration or thermal bridging.

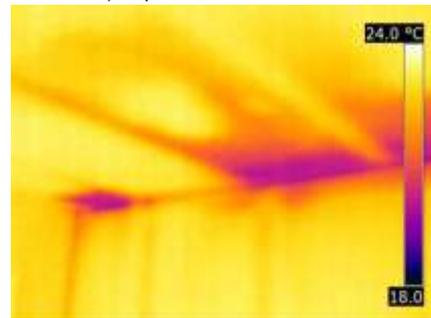
Figure H02 – IR image of ceiling junction in bedroom 2 plot 20, insulation missing on ceiling.

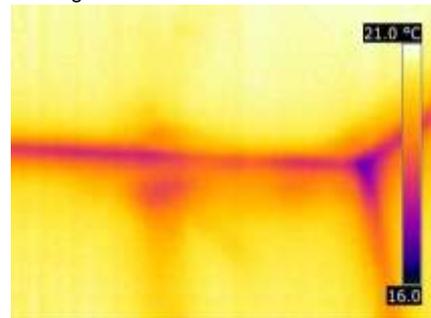
Figure H03 – IR image internal wall and ceiling junction of plot 20 showing heat loss through junction detailing

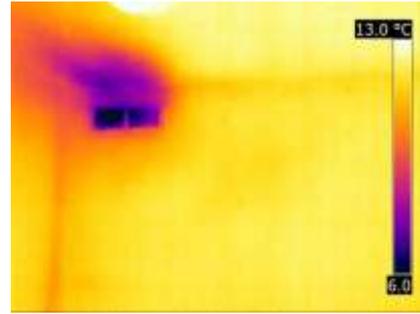
Figure K06 – IR image internal, showing temperature of air passing inward through the breathing wall vent. Thermogram at wall corner and ceiling junction.

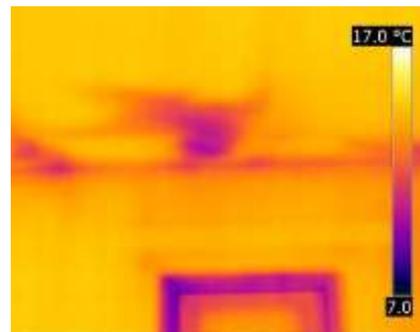
Figure K07 – Missing insulation or thermal bridge in ceiling. Plot 23 bathroom first floor

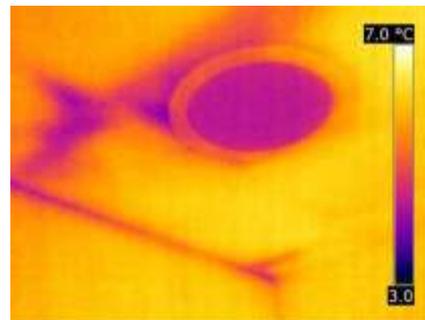
Figure L05 – IR image internal wall, ceiling and sun tube at plot 25, showing thermal irregularities around perimeter of solar light tube

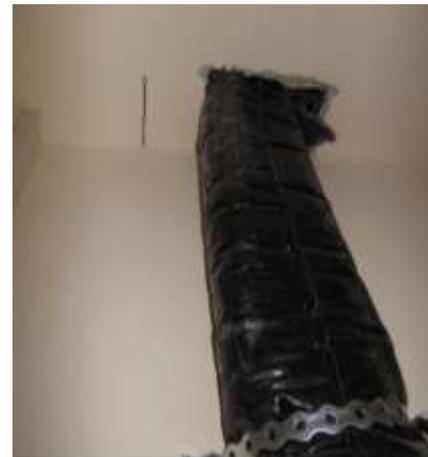
Figure L08– Insulated water pipe work from the solar water collector. Ceiling penetration has not been sealed.

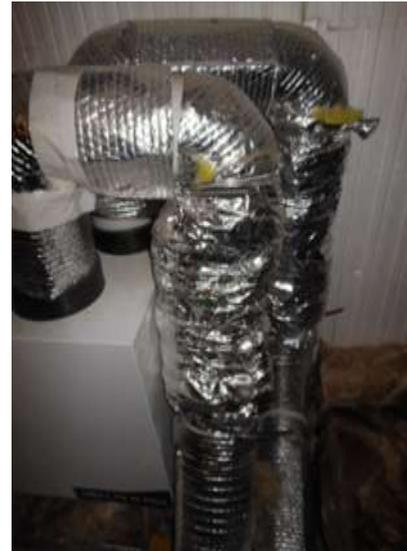
Figure M07 – Ripped foil coated insulation into MVHR unit in plot 33

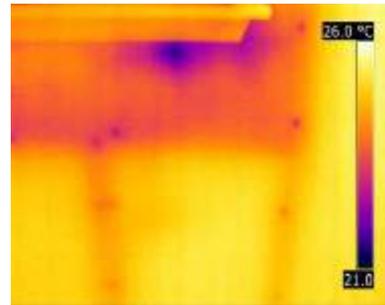
Fig. IR13 – Plot 3 Bedroom

Comments: Thermograms from both plots 3 & 4 show some areas of concern where air infiltration or thermal bridging are facilitating the passage of heat. As can be appreciated in the above images, the surface temperature differences can be in the region of between 3 & 4°C. IR08 shows how wall and floor studs are transmitting heat. Concentrated areas of thermal bridging shown at the base of the wall studs indicate some concern. This is similarly experienced in IR09 in the kitchen behind the cabinets. IR10 shows a stud serving as a support to the above window where there are possibly repeated stud work acting as a thermal bridge. IR11 shows how service ducts are badly insulated and can be an evident pathway of heat loss. Fixings nearby the ducts are also acting as point thermal bridges. IR 13 shows a detail of heat loss appearing under the internal window sill surrounded by stud fixings. IR12 shows the ceiling of plot 3 where intersection between walls shows heat loss but also a structural beam spanning across above the ceiling is also acting as a heat path through possibly thermal bridging. Although the temperature range is not big, there is indication of heat escaping.

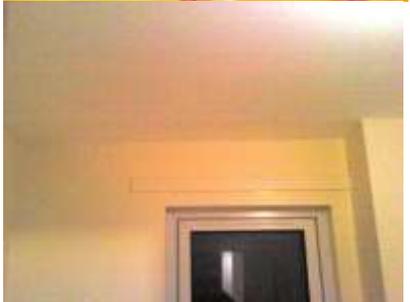
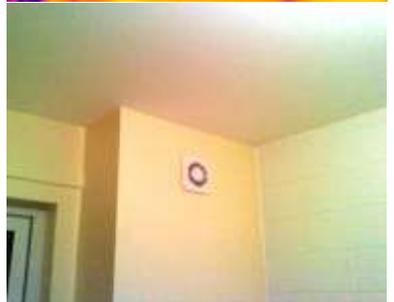
Comments: Internal thermograms of the control house show many concerns around the floor and also on the ceilings in the first floor. Image IR65 is of particular concern where a large un insulated section near the eaves of the roof shows heat loss. There are repeated images where ceiling insulation is badly installed or missing completely. Many of the examples above are near junctions between ceilings and wall where detailing can be complicated. IR66 is interesting as it highlights some concern close to the window and adjacent walls. A large heat loss area is located in the wall/floor junction where an element there appears to be creating a thermal bridge.

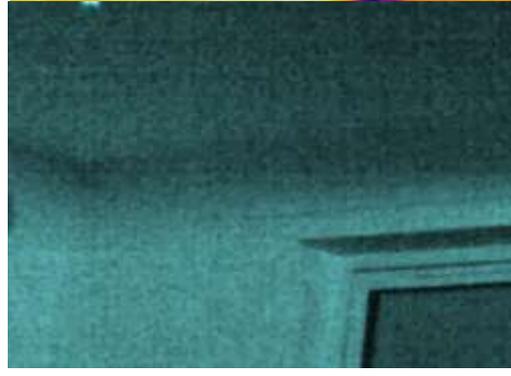
Comments: Internal thermograms of plot 33 show some concerns especially on the ceilings. IR128 shows missing insulation above the flue, which had a larger hole for positioning and was later blocked up. Image IR129 shows heat loss at ceiling level where loft insulation has not reached those areas sufficiently or possibly air infiltration is appearing. IR130 shows a similar example of this. Image IR131 shows the similar eaves ceiling/wall junction but with a greater impact on the corner of the wall where heat loss is experienced beyond the line of the eaves and across a joist or other element creating thermal bridging.
