**CLEANING AND RESTORING OLD MASONRY BUILDINGS  
— INVESTIGATIONS OF PHYSICAL AND CHEMICAL  
CHARACTERISTICS OF MASONRY STONES AND CLAY BRICKS  
DURING CLEANING**

PhD Thesis

**2014**

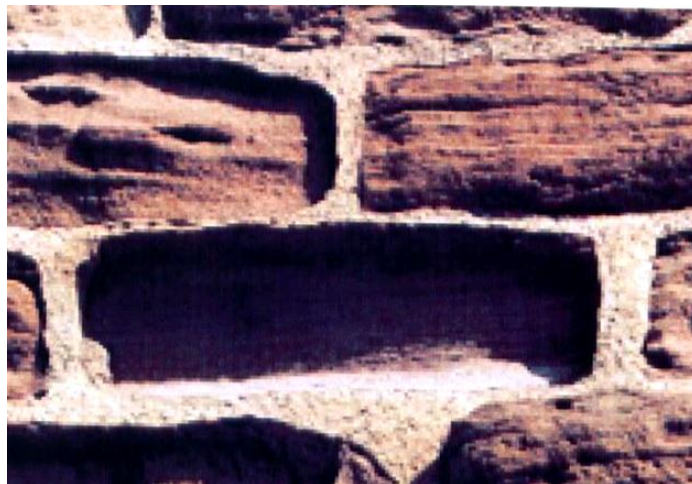
**Fig. 2.12** – Hard mortar causing decay of surrounding stones  
([http://www.nsiuk.org/bwss/stone\\_decay.htm](http://www.nsiuk.org/bwss/stone_decay.htm)).

If a porous stone like sandstone is placed over a less porous stone then the movement of moisture between the two is restricted and depending on the vulnerability of the stone, decaying can occur in the porous stone. Calcareous stones can leach damaging calcium salts into adjacent stones. Care must be taken when laying different types of stones ([http://www.nsiuk.org/bwss/html/stone\\_decay.html](http://www.nsiuk.org/bwss/html/stone_decay.html)).

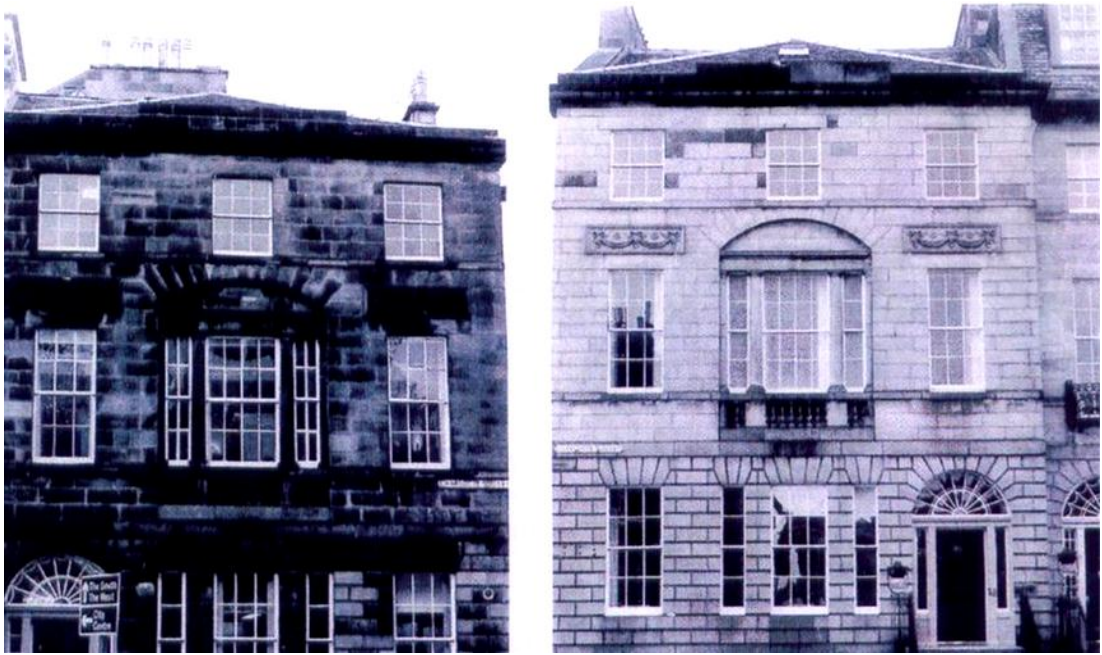
**Fig. 2.14** – Aesthetical reason for stone cleaning: soiled sandstone façade before and after cleaning.

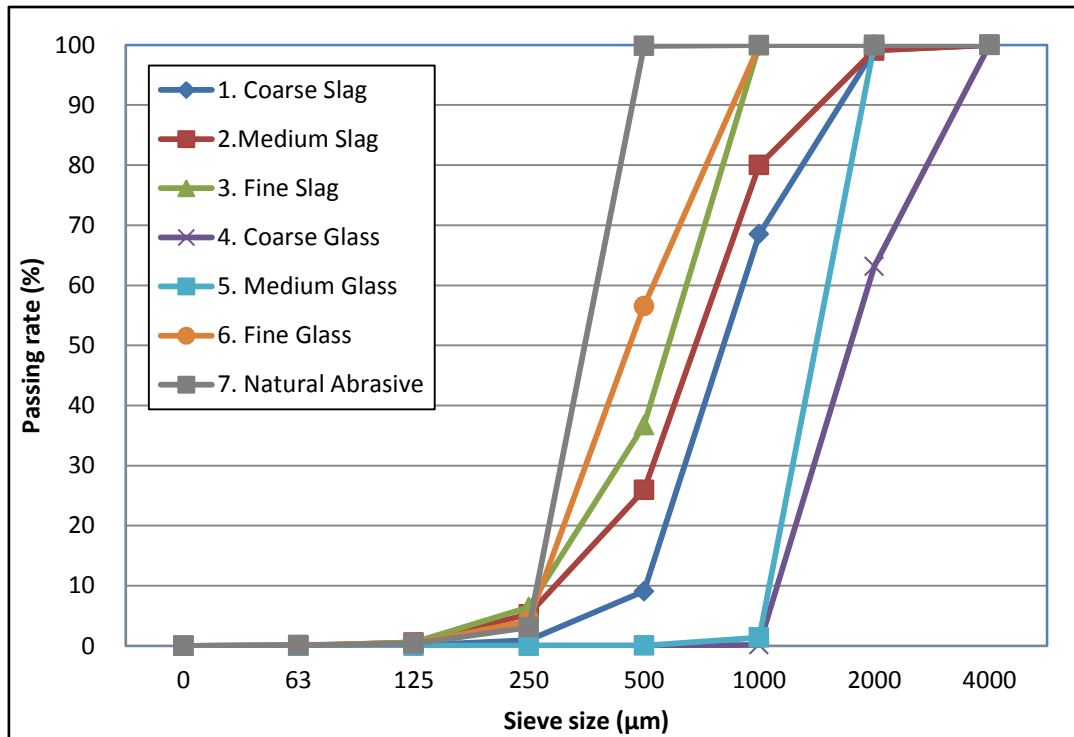
**Fig. 3.17** – Sieve test results before the impact tests for all abrasives.

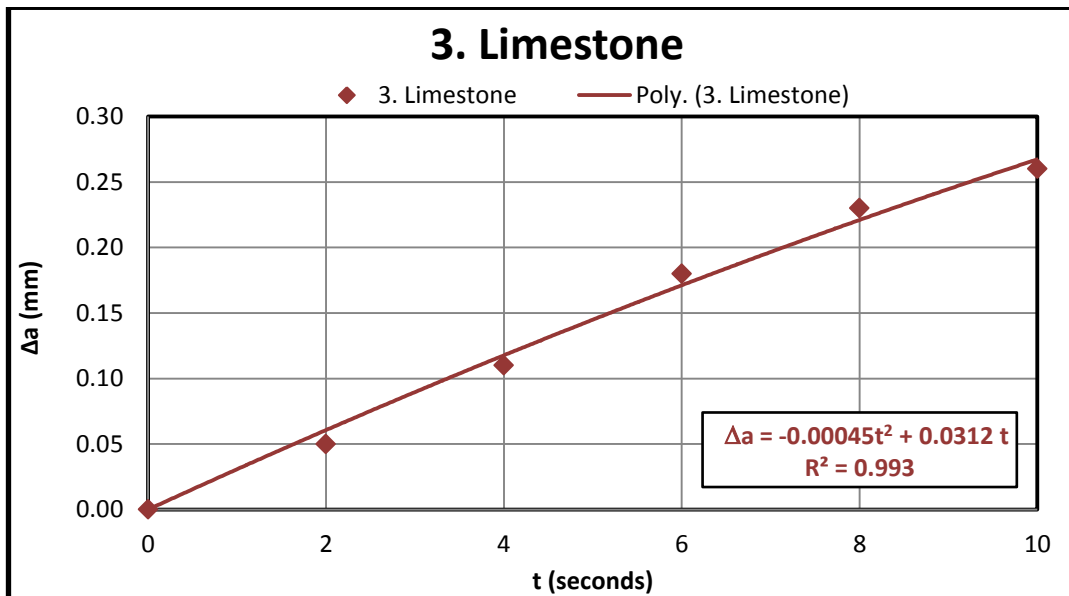
**Fig. 3.20** – Thickness reduction versus cleaning time for the Limestone cleaned with the fine slag.

Several factors governed the amount of materials worn away by the abrasive cleaning. The material properties of the stones and abrasives were the most relevant influential factors. As indicated in Section 3.1, the properties of the selected stones and bricks in this project were largely different. Thus, depending on individual samples, distinct variations in their performance could be expected. Furthermore, Section 3.2 demonstrated that each type of abrasive offered unique characteristics with respect to its size, shape, strength and hardness. On top of these two factors, it is also very important to take into consideration the nature of the soiling on the stones and bricks. Nevertheless, soiling nature was more related to the number of cleaning stage and the time length of cleaning than the thickness reduction, although a relationship between the cleaning stage number and the concurrent thickness reduction was obvious. Figs. 3.20 and 3.21 show different trends of the thickness reduction  $\Delta a$  with the cleaning time  $t$  for two different stones (limestone and marble) cleaned with the same fine slag abrasive.

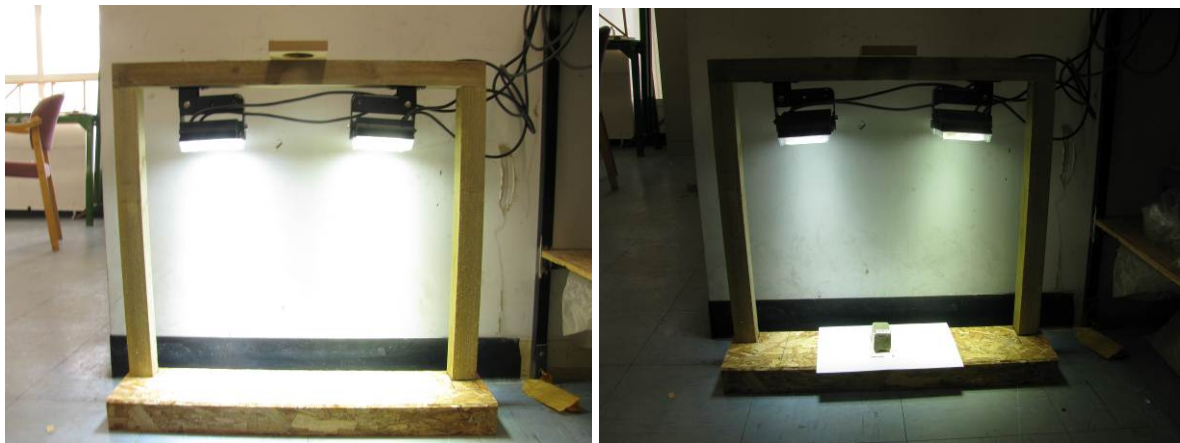
Figure 2: Frame for photo shooting

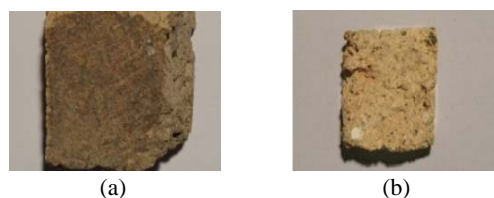
**Fig. 1** Yellow clay brick samples for SEM and EDX testing. (a) fully dirty sample and (b) fully clean sample.
