Determination of Shear Strength of Timber Joists by Torsion Testing

Aamir KHOKHAR¹, Hexin ZHANG², Daniel RIDLEY-ELLIS³

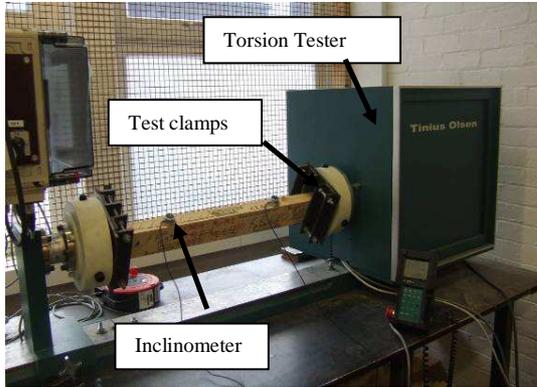
Figure 1: Torsion testing apparatus 1.0m sample

the timber under a torsional load, inclinometers with a range of $\pm 30^\circ$ were attached to the upper edge (45 mm dimension) of each sample, as shown in Fig. 1.

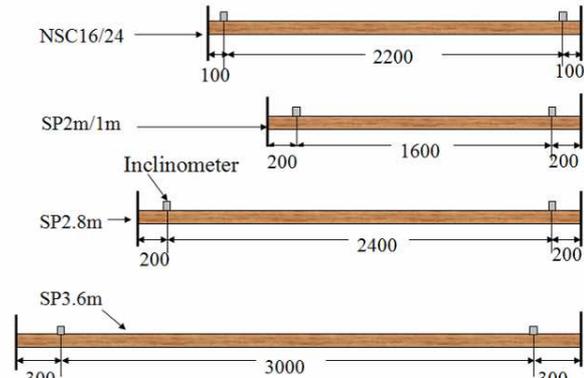
Figure 2: Shear strength test arrangements for SP and NS joists (length in mm)

The mounting positions for the inclinometers depended on the length of sample being tested, but in all cases inclinometers were mounted at least 100 mm (from the clamps to avoid end effects). For 1.0 m long samples, two inclinometers, each located 200 mm from the end clamps allowing displacement to be measured on a 600 mm central span. Fig. 2 gives the positions of inclinometers for each length. The main purpose of mounting inclinometers was to obtain the relative twist of the span free from machine and clamp distortion to calculate shear modulus G . The shear strength was calculated on the basis of the maximum torque. All test specimens were tested at $4^\circ/\text{min}$ (ASTM 1996) until each test specimen was fractured under applied torque. The shear strength and G of each test specimen was calculated on the basis of Saint-Venant torsion theory for rectangular sections as follows:

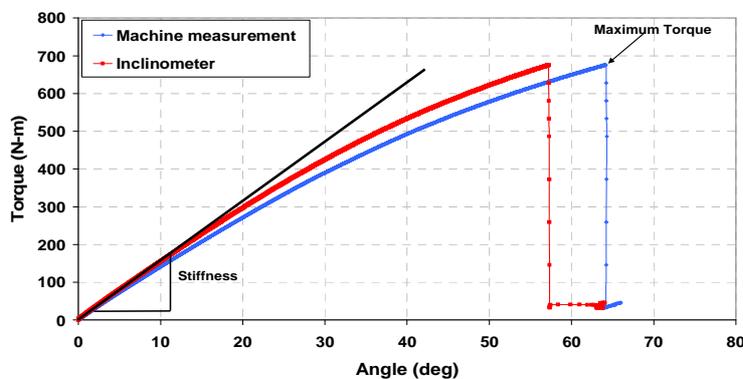
Figure 3: A typical applied torque and relative twist of 2.8m test sample

In Eqs. 2 and 3, d is the depth (major cross-section dimension) and t is the thickness (minor cross-section dimension) of the test specimen and k_1 and k_2 are constant values depend on the depth thickness ratio (see e.g. Bickford 1998) The maximum applied torque is defined as the ultimate applied torque at which test joists were either fractured or reached at their maximum strain hardness point, as shown in Fig. 3. The stiffness was obtained by conducting linear regression analysis of

the applied torque and the relative twist per length within the elastic region as shown in Fig. 3. For most of the tested specimens the elastic region was between 3% and 30% of maximum applied torque, and therefore, linear regression analysis was conducted between 5% and 25% of maximum applied torque to obtain the stiffness.

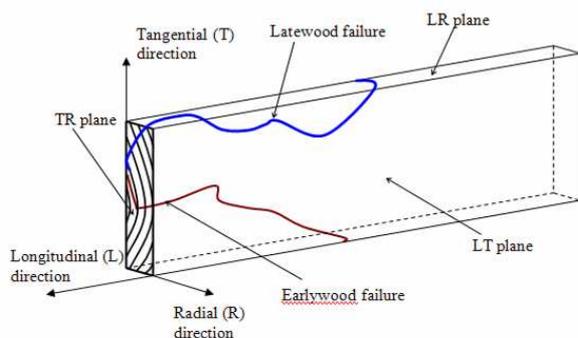
Figure 4: The Schematic diagram of timber joists showing grain direction.

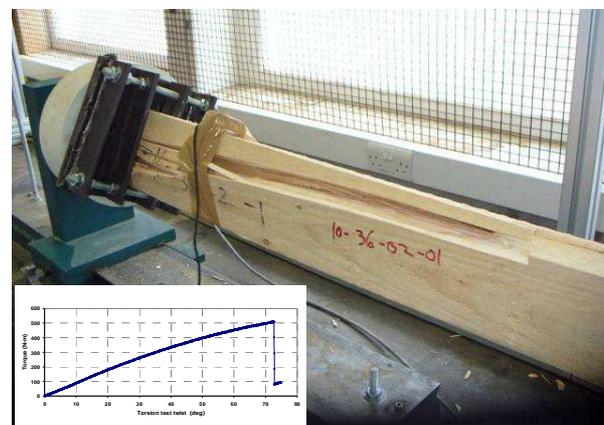
Figure 5: A crushing failure of 3.6m batten and its torque-twist relationship

The crushing failure is defined here as a failure that occurs at the supports due mainly to clamps crushing the wood material. It was noticed that about 50% of SP and NS specimens were crushed at either the loading or reaction supports. The main reason behind crushing of wood was because, in addition of shear stresses, the test clamps induced compressive stresses on the cross sectional area and the combined shear and compressive stresses caused small cracks in growth rings which, in turn, caused crushing failure. The cracks began in earlywood zone in RT plane (Fig. 4) and propagated along LR plane (long side), as shown in Fig 5. In some cases cracks were started in the latewood zone and travelled towards first the LT plane (short side) and then propagated towards the LR plane ended into crushing the material. It was observed that presence of knots, inner bark or pith was causing the discontinuation of the cracks and the battens failed immediately within elastic zone as a brittle failure.

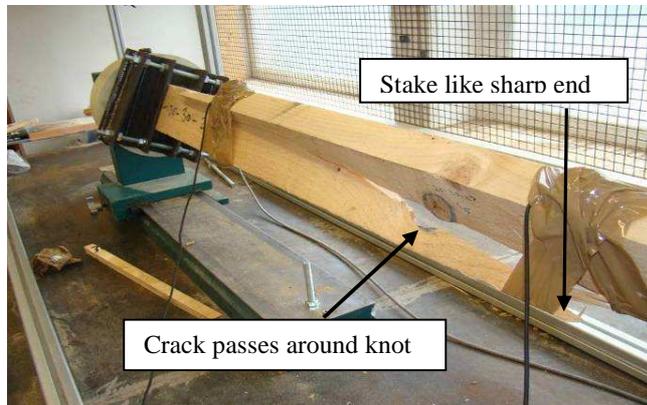
Figure 6: A shear failure occurred in 2.8m joist and crack passed through knot and ends up with sharp edges

The other type of failure mode observed was the shear failure and occurred mostly in Sitka spruce joists. The applied torque produces shear stresses and these stresses were dominant in causing this type of fracture. In the case of clear wood, the shear crack initiated from the middle of the LT plane and propagated towards, and was ended, in the LR plane. This may be because the grain angle might not be parallel to the longitudinal axis and, therefore, the failure travelled diagonally along the grain direction. It was also observed that when crack approaches a knot then the crack travelled across the knot rather than pass through the knot. Thus, this indicates that knot may provide some resistance to the shear failure. Fig. 6 shows a shear failure, and it can be seen that the crack passed around the knot and produced a stake shaped end. In some samples it was observed that combined knot and grain deviation on the LR plane and knot fissures initiated the shear failure and that test joists were fractured within their elastic range as a brittle member.

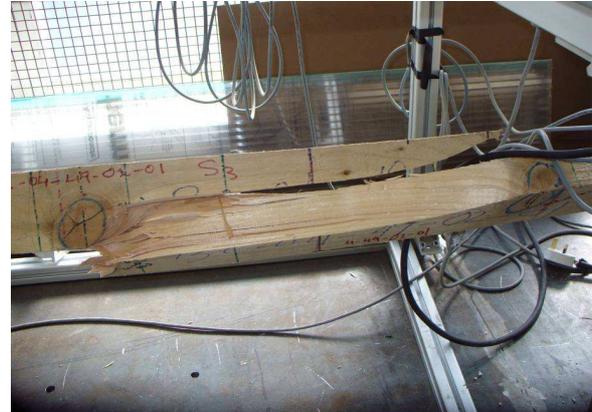
Figure 7: A typical combined tension shear failure occurred in 2.8m specimen due to top and bottom edge knots

Another type of failure that occurred was the combined tension shear failure, which was also mainly observed in the Sitka spruce joists. In this failure mode, the cracks usually were started at either the top or bottom side in tension due to a knot and then propagated as a diagonal crack along the long side and ruptured in tension due to the knot at the other edge. This failure takes place because edge knots are usually surrounded by cross grain and these cross grain broke locally in tension rather than shear and initiated the failure, as shown in Fig. 7. It was found that in this type of the failure the cracks passed around the knots that were present in the long side of the battens. This shows that knots are not the weaker plane along the long side of the battens.

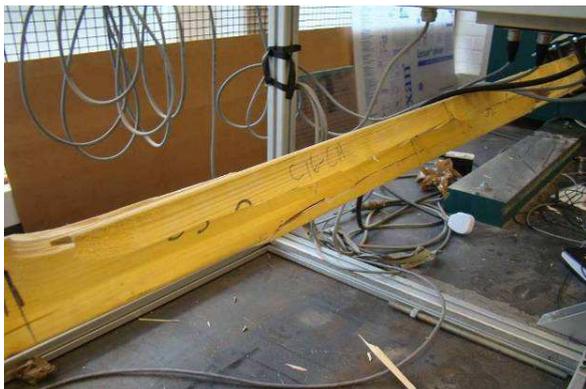
Figure 9: A typical NSC16 batten ruptured under torsion loading with horizontal shear crack

This type of failure was only appeared when Norway spruce specimens were tested. In this type of failure, the shear cracks were usually initiated from clear wood within the LR plane and travelled parallel to the longitudinal direction towards end supports, as shown in Fig 9. The term horizontal shear failure is given here because the shear cracks ran horizontally along the length of the joists. It

is thought that this type of failure occurred because the NS specimens did not have a high slope of grain and that grain direction was completely parallel to the longitudinal axis along the joist span. Therefore, when failure occurred the cracks travelled through grain parallel to the length. Secondly, it was observed that knots diverted the crack path in Sitka spruce specimens but the NS test joists had no large knots (diameter > 25mm) that could have diverted the crack direction. Therefore, the cracks travelled parallel to the longitudinal axis towards the support ends

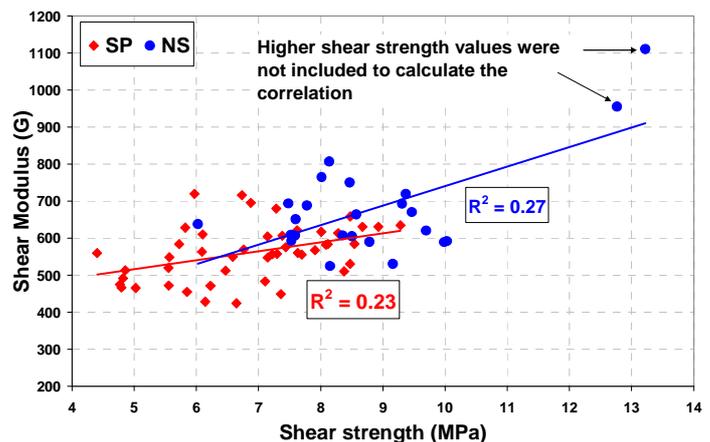
Figure 10: Linear relationship between G and the shear strength of SP and NS battens

In this regard, a linear correlation between the shear strength and G of Sitka spruce (SP) and Norwegian spruce (NS) joists was developed, as shown in Fig. 10. The R-squared values were calculated without including the higher shear strength values of NS test specimens. This is because only two higher shear strength values were obtained and this will unduly bias the correlation of shear strength and the G. It is thought that the slightly higher correlation for NS was obtained because most of NS specimens were free of wood defects and joists failed within clear wood. However it was also noted in this study that knots have very little influence on G and on shear strength overall. Rather, in some SP specimens it was found that knots initiated the failure and caused a low shear strength values but had no major affect on G, which may weaken the correlation.
