# Ethanol driven building fungus colonisation: 'Whisky Black' in urban built environments

### **‘Whisky Black’ on buildings in West Central Scotland**

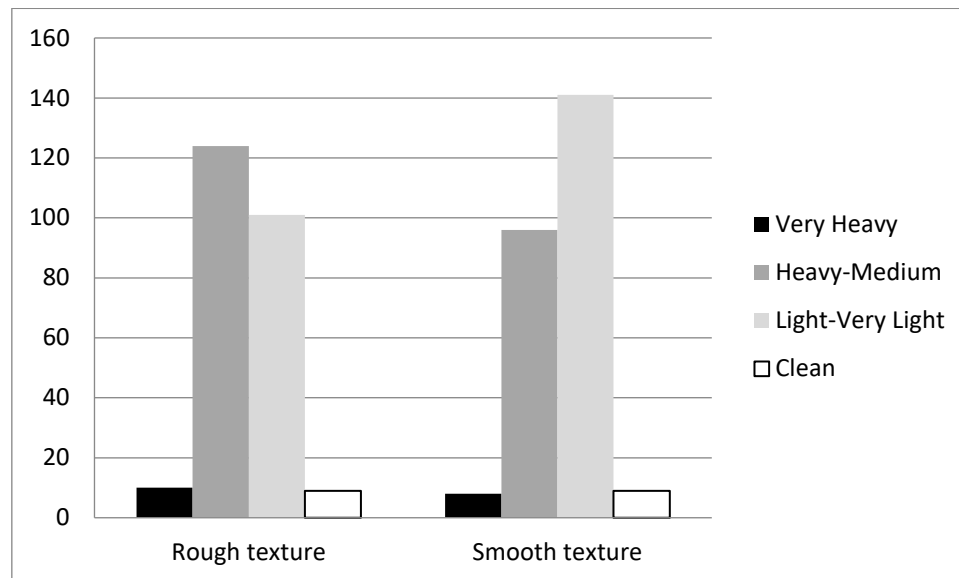
If the construction materials are grouped to reflect their surface texture, then bricks, timber and roughcast would be described as rough; and PVC and re-constituted stone would be described as smooth. Figure 8 illustrates the materials divided into these groups and shows the extent of manifestation on rough textured materials and smooth textured materials. Rough textured materials (for example bricks) exhibit a heavy-medium manifestation more often than those with a smooth texture. Following the same trend, smooth textured materials suffer from a light-very light growth extent more often than those with a rough texture. Therefore, the extent of manifestation of the black fungus is marginally greater on rough textured materials than on smooth textured materials.

**Figure 8:** Extent of manifestation by material texture

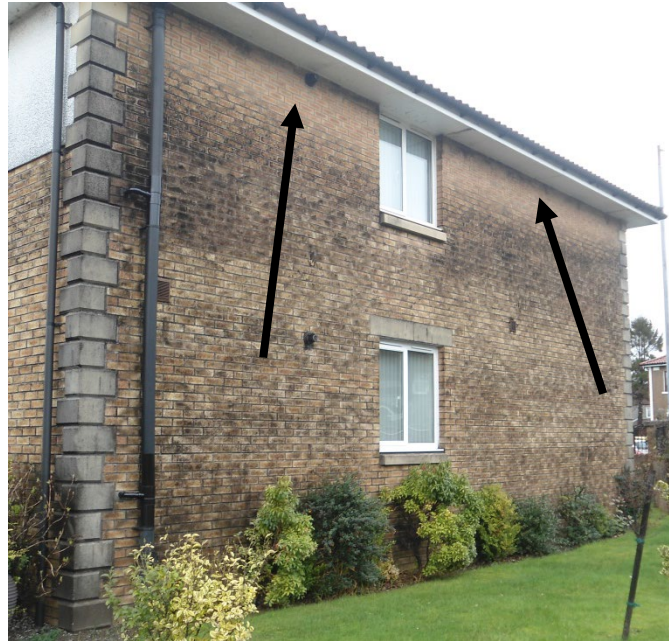
During the visual inspections of the fifty properties some additional observations were made with regard to particular elevations. On the majority of elevations there were areas on which the Whisky fungus was not evident or not evident to the same extent as the rest of the elevation. The areas where the Whisky fungus was not as evident was found to be under the eaves of the roof of the property, or under projecting window cills. Areas sheltered by the eaves varied in size, extending to approximately one metre beneath the eaves on some properties. Areas protected by projecting cills were smaller in size and reached approximately 0.3m beneath the projection. Figure 9 shows the areas beneath the eaves (shown by the black arrows on Figure 9 and the white arrows on Figure 10) and the window cills having a lesser extent of Whisky fungus growth than the remainder of the external wall and therefore the 'soiling' not being uniform across the surface. Figure 10 demonstrates the manifestation of the black fungus on a heavier scale with areas beneath the eaves again not uniform in coverage and also the exterior wall of the integrated garage which had been cleaned of the Whisky fungus. Areas sheltered by eaves and projecting cills will also be protected from rainwater, whereas the rest of the building envelope will be exposed to rainwater. Therefore, this confirms that the Whisky fungus prefers damp climates and requires some degree of moisture in order to grow.

**Figure 9:** Heavy-Medium elevation demonstrating lack of growth beneath the eaves.

Another important factor influencing the prevalence of growth of *B. compniacensis* was associated with building designs, and more specifically the design of weathering detailing such as projecting eaves on pitched roofs and cills around the manifestation. With respect to our results, there were areas surveyed where the fungus was not as prevalent as in other areas, or at least not to the same extent as the rest regarding a particular elevation. The areas of elevations where the fungus was not uniform in manifestation were areas directly beneath the window cills and the eaves of the roof, or areas where the moisture content is lower and the area is protected from rainfall. In contrast, the remainder of the elevation is exposed to the elements, thereby indicating that Whisky Black requires both the ethanol and an increased substrate fabric moisture content to sustain successful growth and propagation. This is in agreement with the proposed life cycle of the fungus requiring liquid water on a surface in order to allow growth (Scott and Summerbell, 2016).

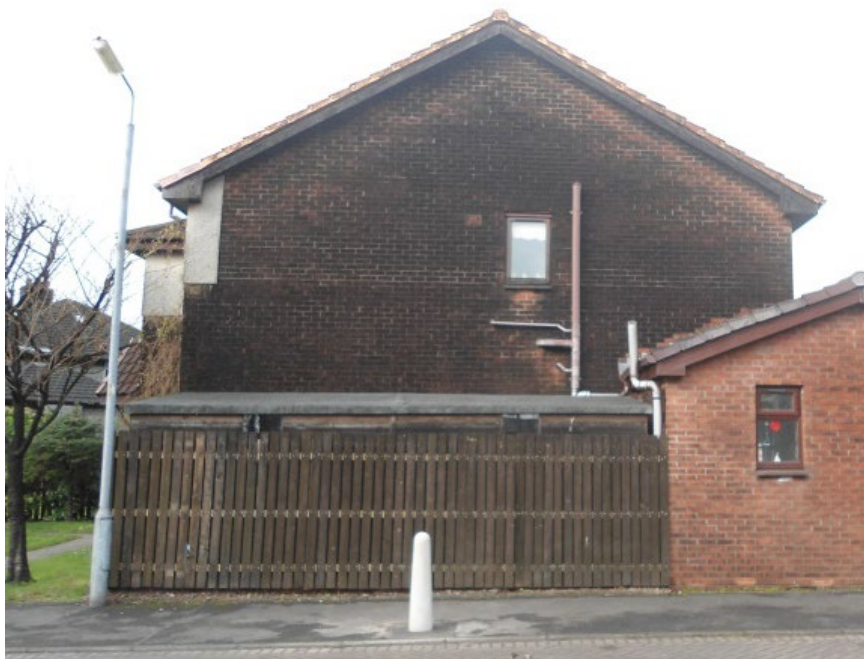
**Figure 10:** Elevation with very heavy growth demonstrating non-uniformity of growth beneath the eaves.
