Investigations of Physical and Chemical Characteristics of Masonry Stones and Bricks during Building Cleaning: Part 2. Chemical Testing

Key words: Masonry stone and brick, sand blasting cleaning, chemical analysis, SEM, EDX.

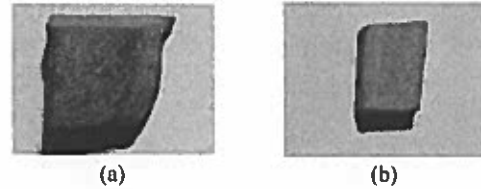
Fig. 1 Yellow clay brick samples for SEM and EDX testing. (a) fully dirty sample and (b) fully clean sample.

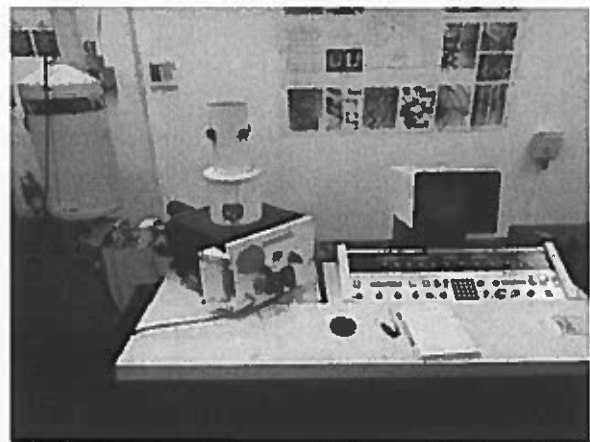
Fig. 5 The SEM and EDX instrument.

In this study, the chemical analysis was conducted by using the instrument with the combined SEM and EDX, as shown in Fig. 5. The instrument used in this study was the SEM LEO S 430 I, UK, coupled with ISIS EDD detector from Oxford Instrument, UK.

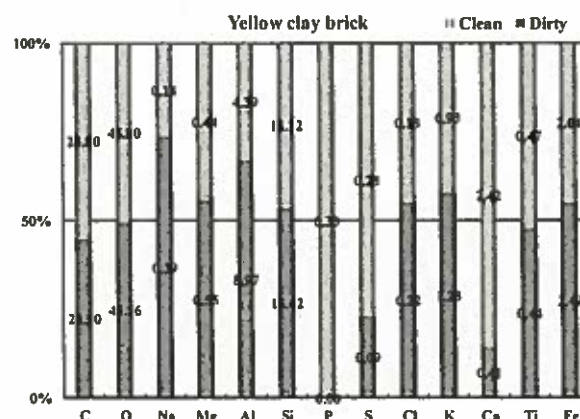
Fig. 8 Chemical elements on the surfaces of the original dirty and fully clean yellow clay brick samples.

Fig. 8 shows the quantities of the chemical elements detected on the original dirty and fully clean surfaces of the yellow clay brick samples. The main chemical elements in the original yellow clay brick were C, O, Si and Al at 23.50%, 45.26%, 16.42% and 8.97%, respectively, which indicates that the main chemical compounds in the yellow clay brick were CaCO₃, SiO₂ and Al₂O₃. By viewing the 50% dividing line, it can also be seen that that C slightly increased to 28.80% after cleaning while Si and Al decreased to 14.12% and 4.39%. As the samples were coated with carbon, it is hard to quantitatively analyse the changes of C. However, the decrease in Si and Al which represent Quartz (SiO₂) and Aluminium oxide (Al₂O₃) through the cleaning process indicates that these two

compounds were formed in the original yellow clay brick. Similarly, the decrease of the rare elements in the yellow clay brick such as Mg and Fe which represent Magnesium oxide (MgO) and Iron disulfide (FeS₂) may be caused by polluting gases like O₃ and H₂S.

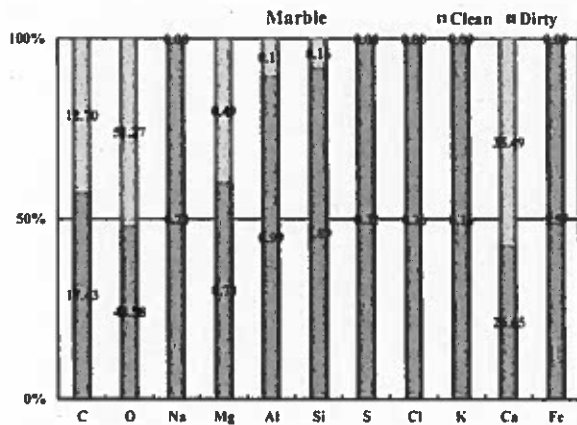
Fig. 17 Chemical elements on the surfaces of the original dirty and fully clean marble samples.

Table 4 lists the relative amounts of the eleven detected chemical elements in percentage by using the EDX for both original dirty and fully clean marble samples. Fig. 17 shows the quantities of the chemical elements detected on the original dirty and fully clean surfaces of the marble samples. The main elements in the clean marble were C, O and Ca at 12.70%, 51.27% and 35.49%, respectively, and the main compounds in the marble were CaCO₃ and Wollas.
