Housing Innovation Showcase 2012 Building Performance Evaluation Phase 1 – Part 1

HOUSING INNOVATION SHOWCASE 2012
affordable ^ sustainable ^ construction

kingdom
housing association

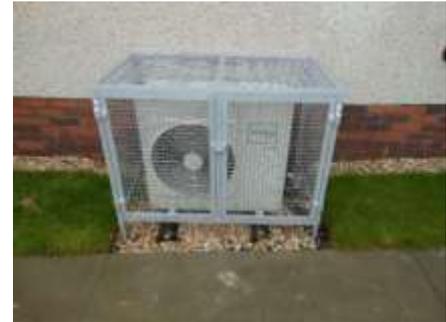
Included in the performance testing was the air source heat pump (ASHP); which was reviewed for its operation and energy consumption. The system is an air-to-water device which is connected to the radiators and hot water. The system also has an immersion heater for back up in cold winter periods. The resident was benefiting from the use of

Figure A07 – Air source heat pump at rear of block 1, used in plot 1

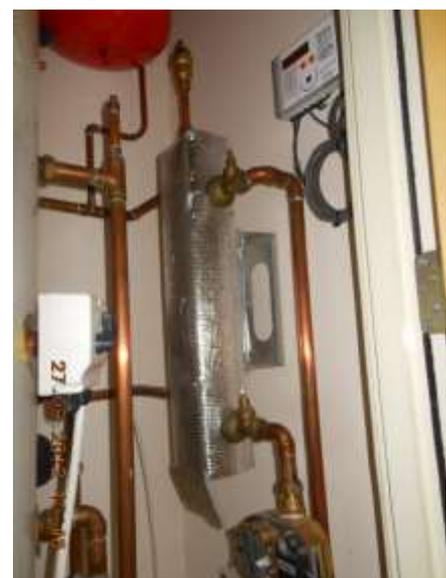
Figure A09 – Pipe work from ASHP and water tank installed in plot 1

the equipment but the heat meter probe used to establish the net benefits of this system was located outside the hot water pipework when it should have been inside; thus not recording adequately the actual consumption values. In terms of its commissioning and operation, the technology at the time of testing appeared to be operating according to design intent.

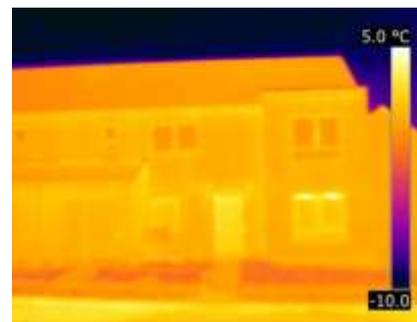
Figure B05 – Front elevation IR image of plot 5 and 6

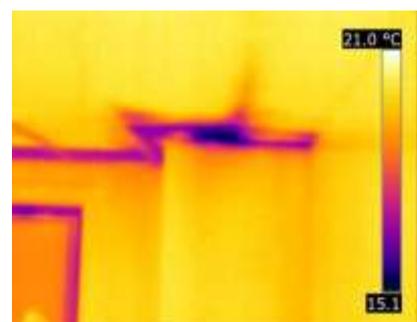
Figure B06 – Internal IR image, ceiling/wall junction in plot 6

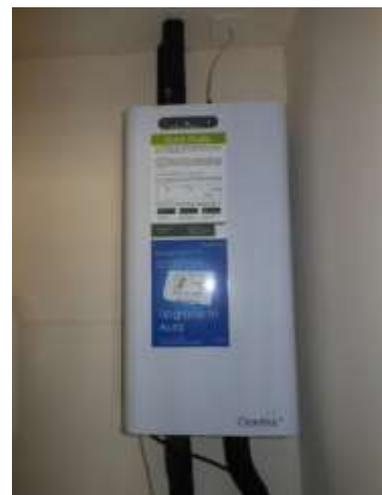
Figure B09 – SHW distribution system

around pipe work is tightly fitted from the tank to the Viridian controller and to the solar panel; however exposed valves and flanges could be further insulated.

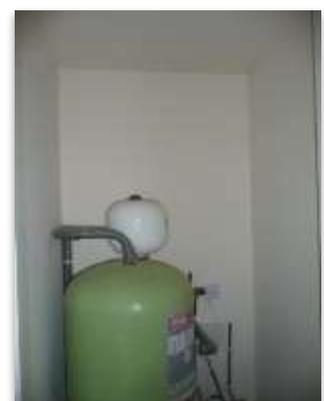
The level of satisfaction with storage space was rated as relatively poor because both storage cupboards contained services such as water storage tank and ventilation equipment. The services encroached on the amount of space left over for storage and this was disliked, particularly given that storage cupboards were not fitted with shelves.

Figure B11- Not enough storage space in a storage cupboard which houses services and lack of shelving in the storage cupboard

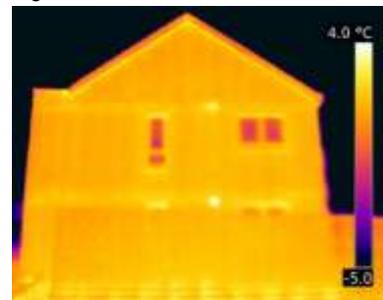
Figure C04 – IR image West elevation plots 9 and 10

Infrared thermographic surveys were performed under the BPE methodology and guidance later explained in page 134 of this Report. Both internal and external images concentrate on plot 9 ground floor & plot 10 first floor. Front elevations showed differences in surface temperatures and heat loss at the junctions. Heat loss was noticeable below the floor level where the brick facing shows temperature differences (Figure C05). Internally, heat loss was identified around skirting's and floor joists (Figure C07). In the first floor flat, insulation appeared to be missing in the ceilings; particularly near roof eaves (Figure C06). This is repeated throughout. Field study results were used to create an as-constructed SAP assessment of the dwellings tested in order to obtain a comparative performance figure.

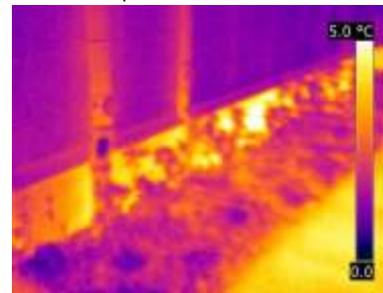
Figure C05 – IR image external wall and ground level in plot 9

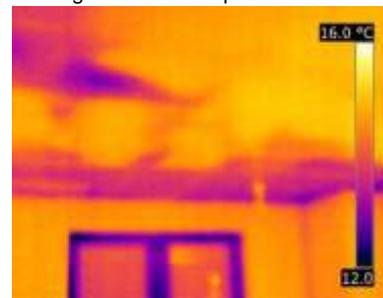
Figure C06 – IR image internal wall and ceiling junction plot 10

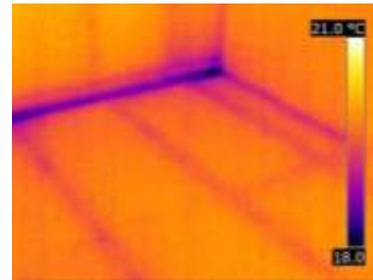
Figure C07 – IR image internal wall corner and floor junction plot 09

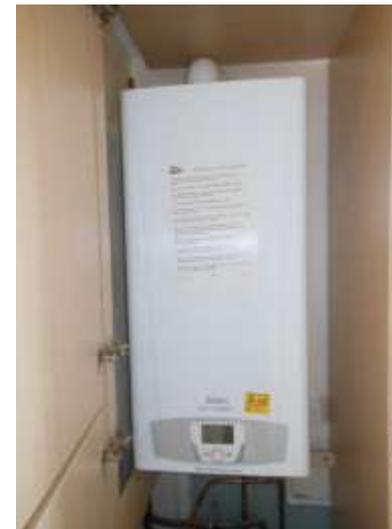
Figure C08 – Boiler installed at plot 12

The mCHP was operational while conducting the survey. Some installation issues were spotted; for example a lack of insulation around pipe work and holes or badly patched up gaps appeared beneath the mCHP which may present air infiltration as these pipes penetrate or are close to the external building fabric. During the inspection, all pipe work was un-insulated

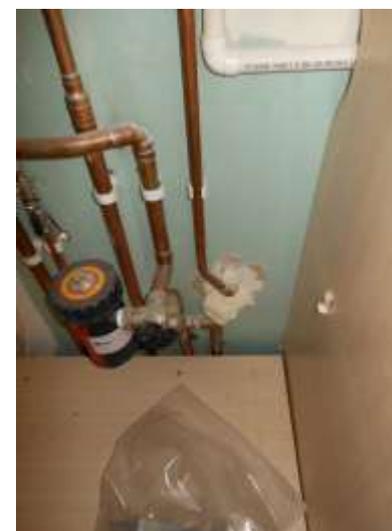
Figure C09 – Pipe configuration at plot 12

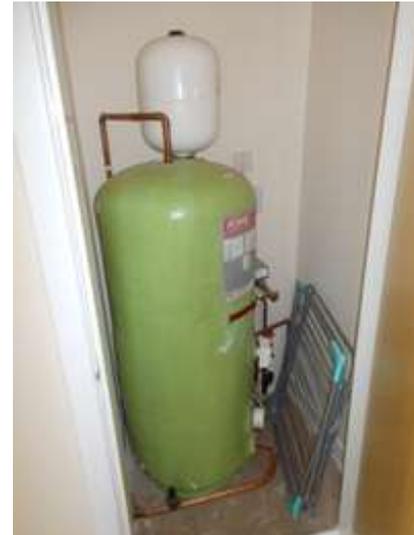
During the second visit to test system performance, the occupier complained that water temperatures were very high and that this was highlighted to the Housing Association, it

was later confirmed that the immersion heater was on override and was constantly on, instead of a timed control as expected. This would increase electricity use throughout this period.

Figure C10 – Hot water tank installed at plot 12

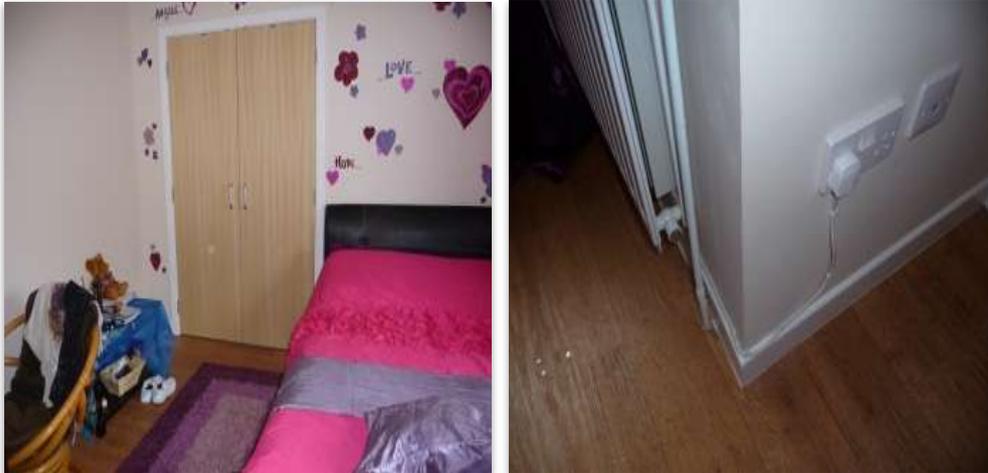
Figures C14 & C15 - The position of the sockets in bedrooms assumes only one arrangement for the bed and this blocks access to the fitted wardrobe. Resident's preferred position for the bed necessitates running an extension cable from the socket by the door to the opposite corner where there is a bedside table.

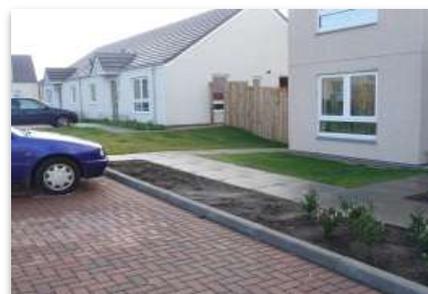
Figure C17 - It would have been better if there were some slabs every now and then to be able to cross over from the car to the pavement in front of the house.

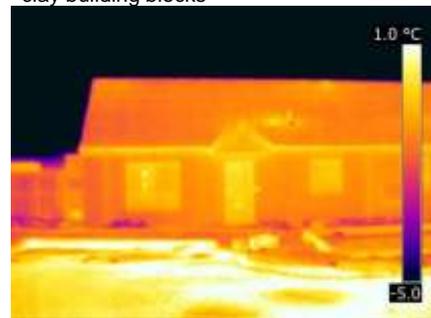
Figure D04 – IR image front elevation of plot 14

Infrared thermographic surveys were performed under the BPE methodology and guidance explained later in page 134 of the technical appendix. Front elevations showed differences in surface temperatures and heat loss at the junctions (Figures D04 & D05). Heat loss was noticeable in areas on the roof and gable wall. Missing insulation near roof eaves and from internal service straps might explain the IR images and the weak heat loss points.

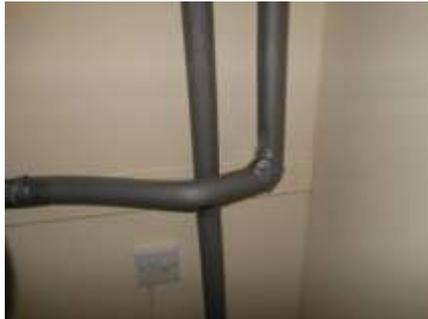
Figure D08 – Pipe work into water tank - plot 13

Water heating was obtained by the use of a conventional combination boiler and a 3kW immersion heater in a 150Lt PowerFlow 2000 water tank. The insulation around the pipework was present but fixed by duct tape that can tend to delaminate easily, especial at high temperatures.

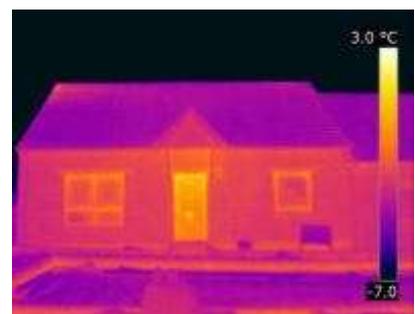
Figure E05 – IR image front [West elevation] plot 16

Infrared thermographic surveys tests were performed under the BPE methodology and guidance explained in page 134 of the technical appendix. Internal and external images were taken from plot 16. Front elevation Figure E05 shows an even distribution of surface temperatures on the main SIP wall system. The roof also shows a relatively even surface temperature, with the exception of the roof top left hand corner; which shows an elevated surface temperature caused by a

steel beam. This is not an issue as the attic space is not habitable and it is not a heated space, if this scenario changes the steel would have to be insulated. Internally it can be seen that the SIP panel used in the ceiling presents some detailing issues. The edge between the wall and the ceiling in Figure E06 shows lower surface temperatures. There are also patches where insulation is missing or a thermal bridge is occurring through the SIP ceiling. Although a warm roof construction; some heat losses are identified.

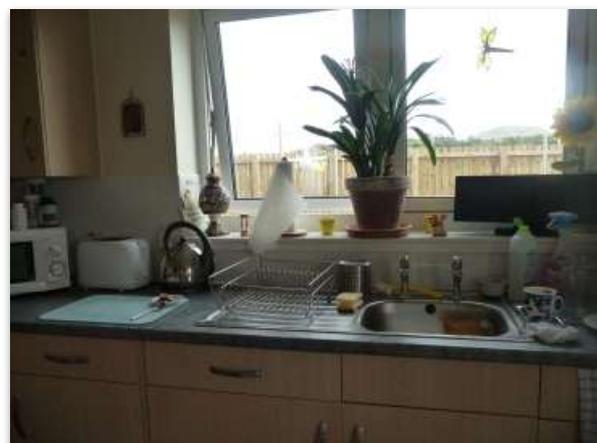
The size of the kitchen was praised, although one resident felt that there is not enough room on the worktop for food preparation. In their view just handing the sink would have resolved the problem: *“that way the drainer would have been on the right hand side of the bowl and there would have been much more space for food preparation closer to the cooker”*.

Figure E13 - In user's opinion just handing the sink would have provided more user friendly solution

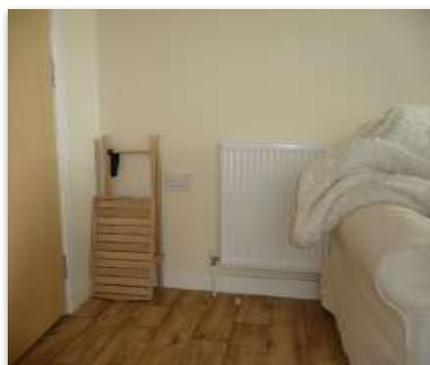
- The radiator in the living room is obstructed by a sofa and
- The radiator is too far from the corner due to a socket positioned in the same corner – in the resident's view again it is wrongly positioned as it results in the sofa covering the radiator.
- Both front and rear door do not provide sufficient security: they could be opened too easily by the children.
- The door to the utility room is wide and takes up valuable space: in the resident's view this door would be better if it were a sliding door; this would free up much space in the utility room

Figure E14 - If the power socket was positioned on the wall behind the door, the radiator could have been positioned closer to the corner, leaving enough space for the sofa not to obstruct the radiator

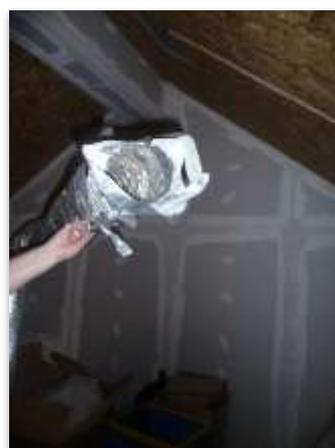
Figure E15 -The MVHR ventilation duct was taped with masking tape and came off

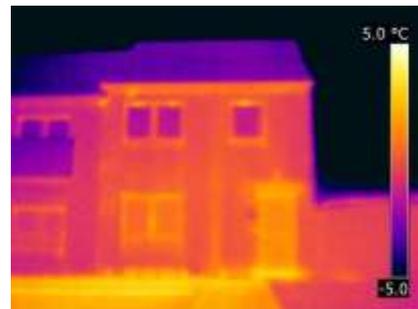
Figure F03 – IR image front (South elevation) of plot 17 and 18 (Passivhaus)

The infrared thermographic surveys were performed under the BPE methodology and guidance explained later in page 134 of the technical appendix. Front elevations showed differences between the two dwellings but overall consistent temperatures. See Figure F03 & F04. Heat loss was remarkably noticeable internally in both dwellings. The control house showed potentially missing insulation in ceilings and skirting boards, Figure F05. Plot 18 showed inconsistencies in detailing around services, Figure 06, and at some junctions. The BPE Study Team was surprised of how many potential heat loss areas were identified in a dwelling such as a Passivhaus. For example Figure F07 in the ceiling close to the eaves of the roof where large insulation patches are missing or a linear thermal bridge is acting as a heat pathway.

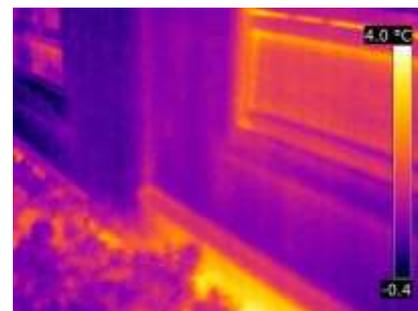
Figure F04 – IR image external, front elevation, living room window, wall and ground level junction. Connection between plot 17 and 18

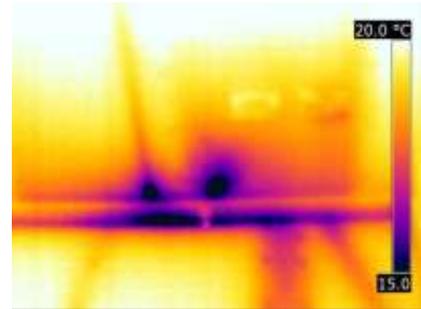
Figure F06 – IR image internal plot 18 wall and floor junction in living room.

- Internal infrared thermography in both plots has shown many first floor ceiling/wall junctions with evident heat loss.
- External thermograms show surface temperature differences between the Passiv Haus and the control house which was evidently expected.
- Both plots show little disparity between the as-built and the as-designed energy use despite the as-built airtightness improvement.

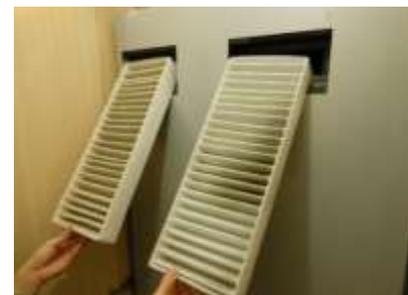
Figure F09– MVHR unit installed in plot 18, filter inspection after early occupation

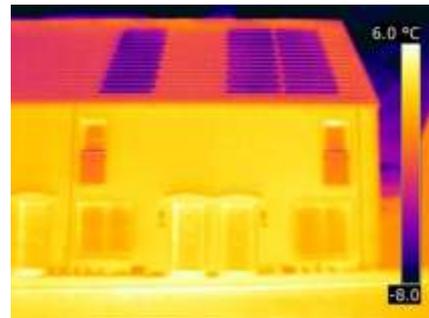
Figure G03 – IR image front (South elevation) of plot 19 and 20

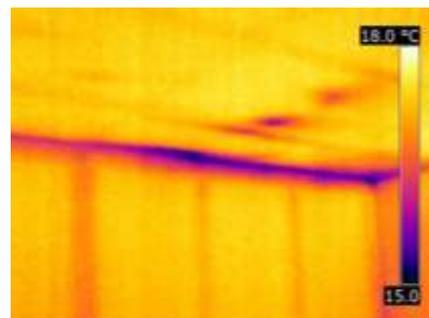
Figure G04 – IR image internal wall and ceiling junction in plot 19 bedroom identifying areas of heat loss in the thermal envelope

- High performing dwelling at design stage with no gas usage for heating purposes. Efficient ASHP at early occupation stages.
- Some heat loss experienced in the first floor ceiling/wall junction observed by the thermograms showing lower surface temperature levels.
- As-designed airtightness figures were not achieved after construction which account to the increase in space heating. Equally higher than floor and roof U-Values has impacted on the annual energy use.

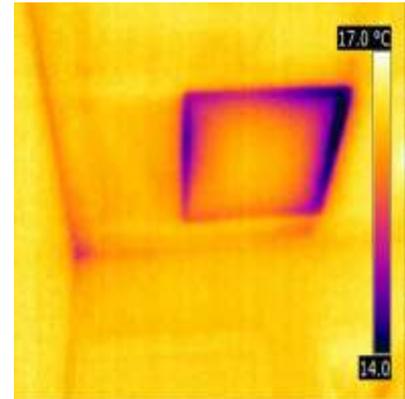
Figure G06 – IR image internal, thermogram shows ventilation heat loss around the perimeter of attic access panel of plot 19 above the landing

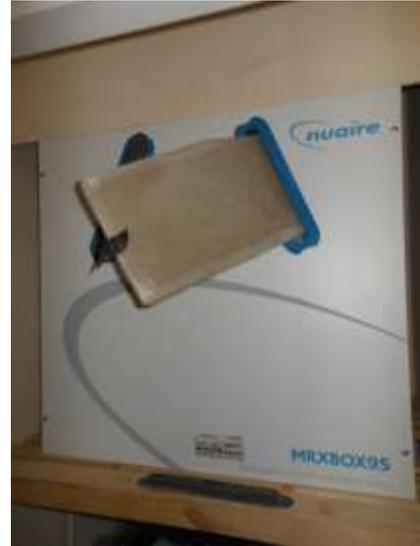
The MVHR is a Nuaire MXMRXBOX95-WH1 system which was tested for efficiency. The field study monitoring in both boost and standard settings gave an efficiency of 81% compared with the manufacturer’s efficiency of 91%. The system was surveyed to make sure it is still performing as the commissioning sheets reported on prior to occupation.

Figure H04– MVHR unit installed in plot 20, filter inspection

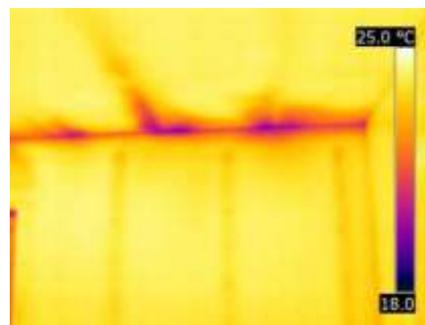
Figure J03 – IR image internal wall and ceiling junction plot 21 Bedroom 2

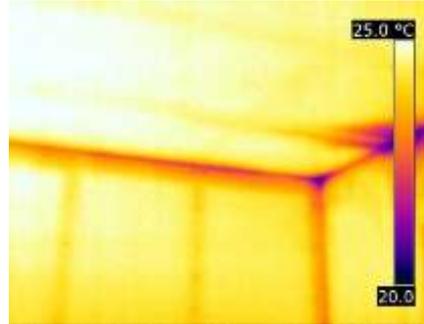
Figure J04 – IR image internal wall/ceiling junction plot 21

- Higher expected consumption of energy for space heating than originally designed. Due to higher air tightness score and the roof/floor thermal U-values.
- Lack of detailing around ceiling/wall junctions as well as around the roof hatch to the attic. This is shown in the thermograms where heat loss is experienced.
- The ventilation system recorded a lower efficiency than the one stated by the manufacturer – installation and user elements have caused this decrease.

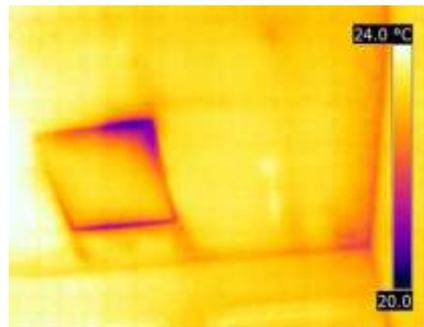
Figure J05 – IR image, internal attic access hatch in landing ceiling plot 21, identifying heat loss at points in hatch perimeter

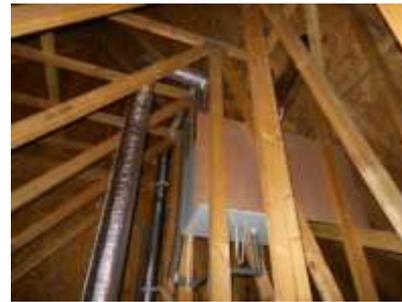
The MVHR is a Nuair MXMRXBOX95-WH1 system that has been tested in this property under the standard and boost settings. The field study monitoring in both settings gave an efficiency of 81%. The system was surveyed to make sure it is still performing as the commissioning sheets reported on prior to occupation. This proved to be correct and in working order. The outside penetration of the extract duct was sealed inadequately and some pipe work was badly insulated, as it was fixed with tape that is now de-laminating; uncovering the ducting and creating heat loss and possible condensation (being in an unheated attic space). The remainder of the pipe & duct work appeared to be properly insulated.

Figure J07 – Installed MVHR unit in attic, plot 21 showing foil insulate ducting

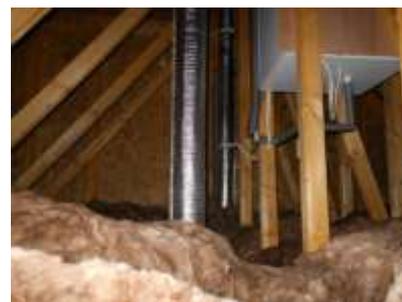
Figure J09 – Ceiling insulation, cold roof space in plot 21

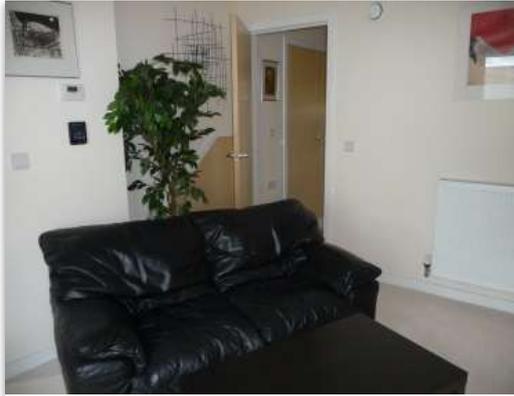
This resulted in poor scores for **living room** meeting residents' needs at 5.5/10 – one of the lowest average scores across Dunlin Drive: *"The living room is too small. It is meant to be for 4 people but it is just Ok for me and my daughter. If we have visitors they have nowhere to sit down. I can arrange my sofa only one way because the radiator is in the wrong place. It should be under the window - this would free another wall for a couch. The way it is - is impossible to arrange furniture"*.

Figures J11 & J12 - The living room is not only too small but also, the positions of the radiator, sockets, the programmer and the Energy Display System, make it tricky to arrange furniture.

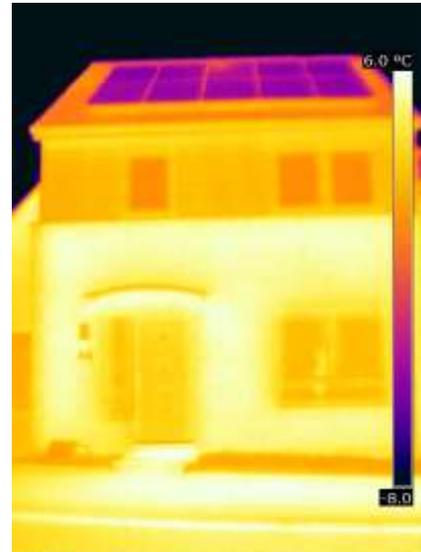
Figure K03 – IR image front (West elevation) of plot 23

The infrared thermography tests were performed under the methodology and guidance explained in page 134 of the technical appendix. External front elevation analysis shows a distinct difference between the timber cladding and the rendered wall which appears with higher surface temperatures, this is likely due partly to the differing emissivity of the materials. The junction between plot 22 and 23 (party wall) also appeared to be showing heat loss as higher temperature gradients have been detected, see Figure K04. Indoor analysis shows some potentially missing insulation in the ceiling near the eaves of the roof, see Figure K05. Air is also entering the rooms through the breathable wall vents at around 6°C which is lower than internal surface temperatures, see Figure K06.

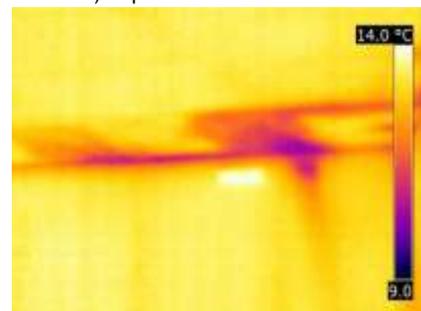
Figure K05 – IR image internal, showing thermal anomaly at wall and ceiling junction witnessed at plot 23

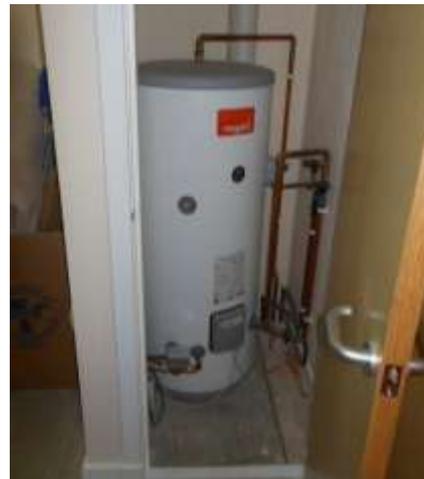
Figure K08 – Hot water tank installed at plot 23

The hot water supply temperature to a bath or wash basin should be limited to a maximum of 48°C. Testing of the delivery at one minute intervals gave an average temperature of 58.6°C at the tap of the kitchen sink, which is above the threshold and could cause scalding to occupiers. KHA will carry out programmed testing of these temperatures. The majority of light fittings were equipped with energy efficient light bulbs which fulfils SAP minimum score of 75% of low consumption light bulbs.

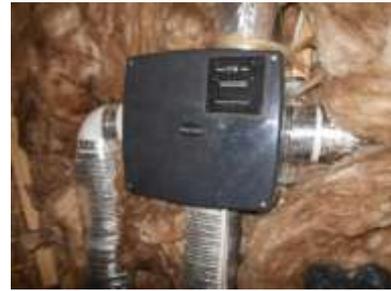
The dwelling is equipped with a Vent Axia Lo-Carbon MVDC-MSH ventilation MEV system. The device proved to be in working order and as initially commissioned. It is located in the attic in an un-heated space. Most duct work is insulated and placed in between the ceiling insulation, see Figure K08. It was observed that a lack of insulation installed on duct 90° bends into the unit has been badly detailed. It was evident that one of the ducts penetrating the roof was poorly finished with holes around it. It was also evident that where the solar tube penetrates the roof it permits light into the attic allowing rain water ingress, see Figure K07. Access to the unit is through an attic hatch which makes maintenance more complicated. Insulation around some ducts was missing at junctions and turns.

Figure K10 – Extractor system installed in attic space of plot 23.

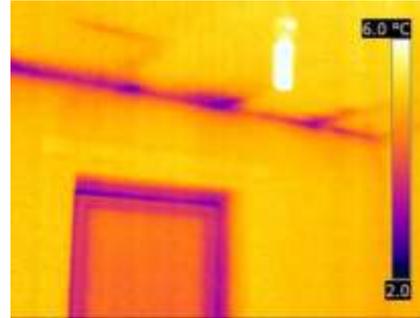
The hybrid or PVT system is produced by Newform energy & Solimpeks. The model installed is a Volther Powervolt 10 x 190Wp Monocrystalline panels providing a total of 1.9kW Solar PV system. The thermal aspect of the hybrid panel is a 10 x 460Wp flat plate system with a total output of 4.6kW (Figure L05). During the monitoring period, the Solar PV panels produced 158kWh of energy. The total global irradiation for that roof orientation and angle was calculated to be 1,120kWh during the month of August. This gives a system efficiency of 14%. Solar thermal efficiency was not calculated as no output from the energy logging equipment could be obtained. The system appeared to be installed adequately although there was some ducting and ceiling penetrations that were not finished effectively (Figure L06).

Figure L06– IR image internal, showing irregular surface temperature difference at window, and ceiling junction at plot 25

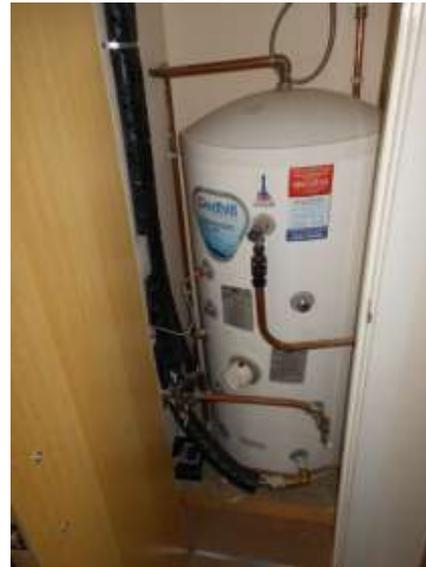
The hot water supply temperature to a bath or wash basin should be limited to a maximum of 48°C. Our testing of one minute intervals gave an average temperature of

58°C which is above the threshold and could cause scalding to occupiers. KHA will carry out programmed testing of these temperatures.

Figure L09 – Hot water tank installed in plot 24

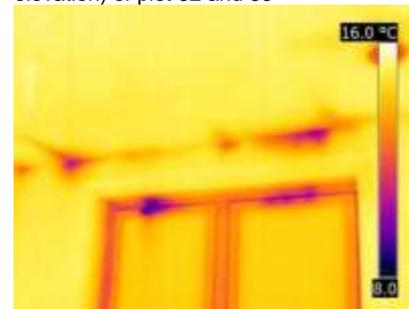
Figure M06 –Internal IR image, heat loss on ceiling/wall junction, captured in bedroom 2 plot 33

Internally it was difficult to identify the many apparent heat loss patches and cold bridging. The double leaf polystyrene wall with a cavity filled concrete core, restricted thermal transmittance by thermal inertia (concrete) and the insulations high thermal resistance. Some heat loss was identified at the ceiling level near the roof eaves where insulation is not reaching smaller areas or perhaps indicates some air leakage.

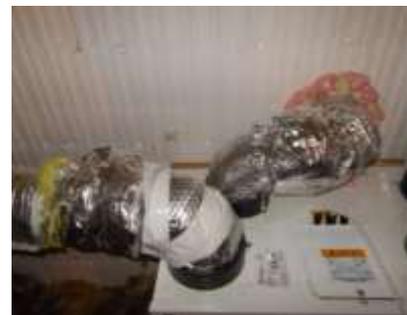
The MVHR is a Titon HRV1.75 Q Plus system which in the early occupation testing was operational and delivering comfortable temperatures. The efficiency recorded was of 78% in standard mode (boost mode installed post-testing), compared to the manufacturer's quoted efficiency of 91%. During inspection of the device it was noted that the duct work installed to the air handling unit was insulated but workmanship issues were identified. Flexible ducting (pre-insulated) was ripped and tightly fixed which could create apertures in the future and underperformance.

Figure M08 – Insulation and coating applied to ducting of MVHR unit plot 33

The use of adhesive tape in joints was also spotted, which could de-laminate in the coming years. Foam insulation to fill duct holes was used, which looks unsightly and exaggerated.

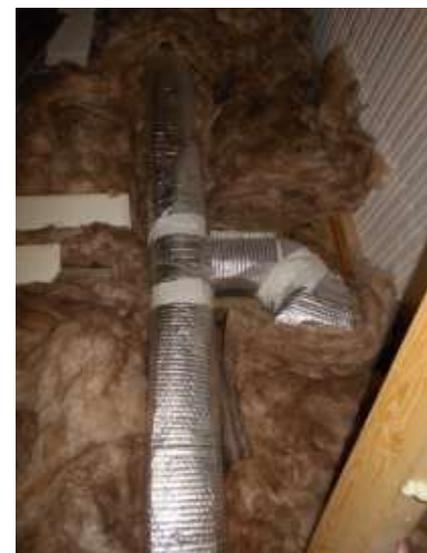
Figure M09 – Ceiling insulation and air handling ducting, plot 33

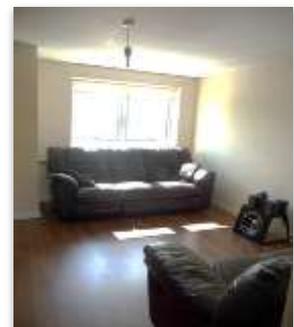
Another resident (plot 32) was dissatisfied and scored layout 4 out of 10, with key reason for the low score relating to a relatively small **living room**. However, overall, satisfaction with the **layout design** of this system was high, although the smallest bedroom over the stairs was reported to have awkward storage space.

Figure M12 - Living room is too small for the whole family to sit together and it is not easy to place a TV set.

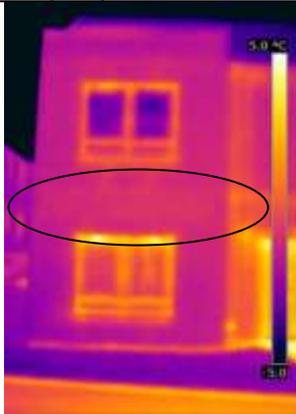
Fig. IR01 – Front elevation

Comments: The external infra-red thermography images demonstrate junction details where higher surface temperatures are experienced. Figures IR01 & IR02 show intermediate floor/ceiling junction temperature variations of up to 2°C. This can also be perceived in Figure IR05 & IR04 at the north & front elevations where a horizontal zone & a vertical line (wall studs transmitting heat) marks heat loss. Figures IR07 show images of the side wall entrance lobby to plot 3. Distinct increase of surface temperatures is experienced all across the wall particularly at the wall junction with the main building volume. Detail 02 and other details supplied show where in the roof void there may be a thermal bridge. IR03 shows the base of the wall (plinth) where increased surface temperatures at the floor shows heat loss. In Detail 01 insulation stops close to the steel floor beam, transmitting heat & acting as a thermal bridge.

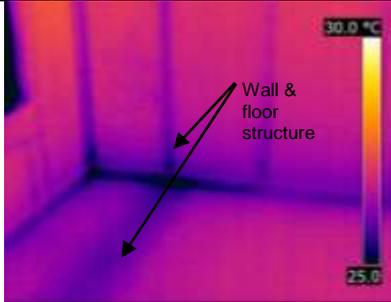
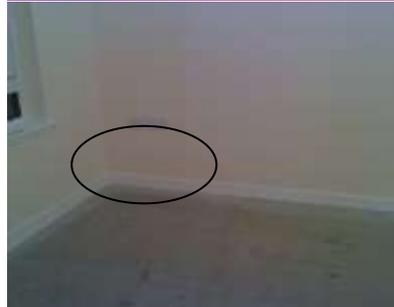
Fig. IR08 – Plot 4 living room

Comments: Thermograms from both plots 3 & 4 show some areas of concern where air infiltration or thermal bridging are facilitating the passage of heat. As can be appreciated in the above images, the surface temperature differences can be in the region of between 3 & 4°C. IR08 shows how wall and floor studs are transmitting heat. Concentrated areas of thermal bridging shown at the base of the wall studs indicate some concern. This is similarly experienced in IR09 in the kitchen behind the cabinets. IR10 shows a stud serving as a support to the above window where there are possibly repeated stud work acting as a thermal bridge. IR11 shows how service ducts are badly insulated and can be an evident pathway of heat loss. Fixings nearby the ducts are also acting as point thermal bridges. IR 13 shows a detail of heat loss appearing under the internal window sill surrounded by stud fixings. IR12 shows the ceiling of plot 3 where intersection between walls shows heat loss but also a structural beam spanning across above the ceiling is also acting as a heat path through possibly thermal bridging. Although the temperature range is not big, there is indication of heat escaping.

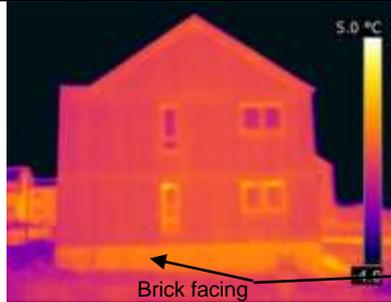
Fig. IR15 – Side elevation plots 5 & 6

Comments: As can be appreciated in the above images, there are concerns over the perimeter facing brick under the floor. Thermograms IR15, IR16, IR17 & IR18 show at different scales the band of heat escaping underneath the flats. Looking closely at the design drawings in detail 03 above, it is clear that provision of insulation is drawn in such a way that it overlaps the floor insulation. This would have decreased any possibility of heat escaping in that junction transmitting itself down the brick facing. There is a big distinction between the walls of the flats and this brick facing. This heat may lead to simply indicating that temperatures under the floor are higher than externally, conductance of heat from a large floor area will increase the air in this void which is shown to conduct to colder brick surfaces. IR19 shows a different concern, where the roof of the entrance lobby which is only insulated at ceiling level, shows heat loss at the junction point. It is also interesting to point out hot surface temperatures of the lobby wall are higher than the rest of the walls in the flats.

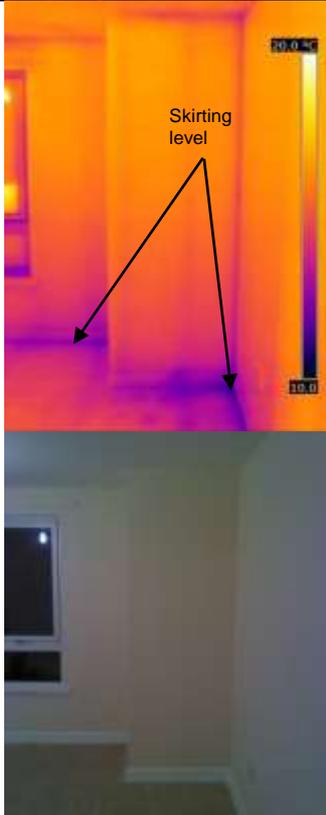
Fig. IR20 – Plot 5 living room

Comments: Internal thermograms shown above indicate some concerns at skirting level and at ceilings where missing or misplaced insulation or thermal bridging of structural elements have created heat loss. IR20 shows how in plot 5 skirting levels have highlighted heat loss. Thermograms of the top flat in plot 6 show some concerns around ceiling levels. IR21 clearly indicates missing insulation or insulation that hasn't been placed correctly. Image IR22 is similar to IR23 where missing or misplaced insulation near the eaves and wall/ceiling junction show areas of heat loss conducting through joists. Image IR24 shows repeated joists close to walls where insulation could not be installed. IR25 is a detailed image of this joist which affects a wider area around it from conducting elements.

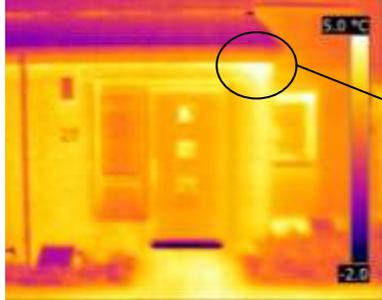
Fig. IR25 – Front elevation

Comments: These external thermograms show three potential heat loss problems. The first is shown in images IR25 & IR26 where the entrance lobby to flat 10 shows heat loss at the junction between the side wall of the lobby and the connecting wall. Details show that insulation reaches only the ceiling level of that sloping mono-pitch roof and it is at these points where heat is escaping. IR 26, 27 & 28 show another area of concern; where the brick base course is exposed and heat conducting itself from the concrete slab where little insulation is positioned; as seen in detail 05. The sole plate conducts heat to the concrete slab and heat escapes as a thermal bridge. A third concern is displayed in IR30 where external wall images show higher surface temperatures at the ceiling and intermediate floors of the flats. Detail 04 shows how sole plate and floor panels indicate heat conduction originating from the half-filled floor.

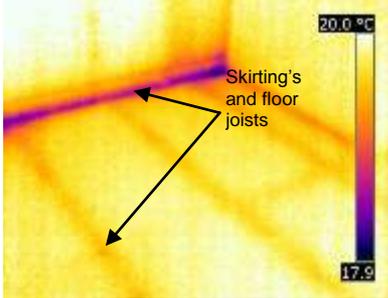
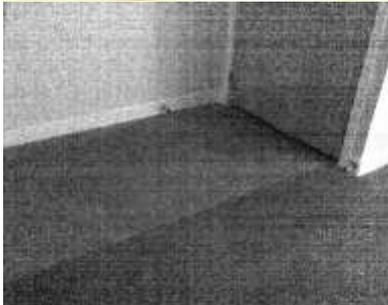
Fig. IR31 – Plot 9 GF Bedroom

Comments: Thermograms in the two dwellings demonstrate some concerns around services where possible installations may be producing thermal bridging or skirting's and floor joists where Thermal bridging is also appearing. Image IR31 demonstrates heat loss at the skirting connection between wall and floor. The first floor property, plot 10, shows some concerning issues around the ceilings close to the eaves of roofs. Image IR32 begins to show possible missing insulation and a circular patch where a blocked service point may be located which is showing heat loss. The rest of the images from IR33 to IR 38 show a repeated trend in the ceilings of the bedrooms and the living room, as well as the bathroom. There appear to be patches of misplaced or missing insulation close to the wall and where the eaves meet. Large patches are shown, for example IR34 and IR38. They all show how heat loss as a concern, especially in the depth that it reaches into the rooms in between ceiling joists. The majority of these heat loss patches appear across the ceiling from one side to the other indicating that heat is escaping or that air infiltration is creating heat loss pathways. Although the temperature variation is not large, there is still a different of 2 to 3°C which is significant in the performance of the dwelling.

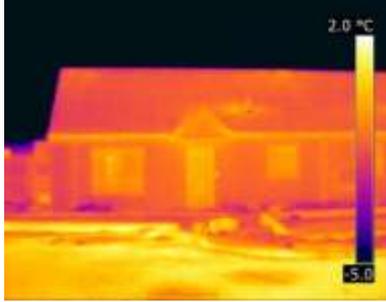
Fig. IR39 – Front elevation plot 14

Comments: The external thermograms show an even distribution of surface temperatures. There are some concerns in the gable end of the two dwellings where small patches of higher surface temperatures appear. IR40 & IR41 show this to some degree where a difference of 1 to 2°C can be observed. Analysing detail 06, the ventilated cold roof shows little indication of the reasons to these patches of higher surface temperatures. A possibility is the placement of the ridge batten and adjoining timber elements that at this point are creating a small thermal bridge. The space behind it is un-occupied and un-heated therefore no big risk is identified. Another area of concern is the perimeter wall brick base course that appears to be showing higher surface temperatures. Images IR42 to IR44 show this repeated problem all-round the building. Detail 07 shows insulation is placed in front of the concrete slab with pebble dash render when in fact it has a brick base course as shown in IR43.

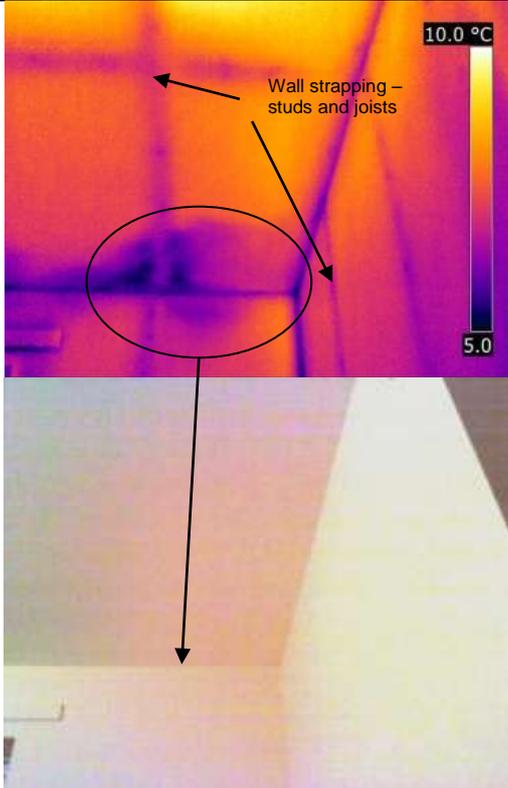
Fig. IR45 – Plot 14 Living room

Comments: The internal thermograms show some concerns at skirting level and ceiling/ eaves level. Image IR47 shows a large patch of lower surface temperatures where possible un-controlled ventilation appears and where insulation may be missing or is installed leaving gaps. Wall/ ceiling straps are shown all-round which may be due to the way the rigid insulation behind it has been placed. Details show the straps on top of the insulation and the image shows that possibly insulation was placed in between the straps creating a small thermal bridge. IR46 also shows some additional circular patches where services are penetrating or have been cancelled. Image IR47 shows a different concern. At the base of the wall at skirting level, a large heat loss patch appears migrating upwards. IR48 shows some concerns above the kitchen cabinet where heat loss is experienced on the ceiling branching over and conducting through the ceiling joists. The same is experienced in thermogram IR45 in the living room.

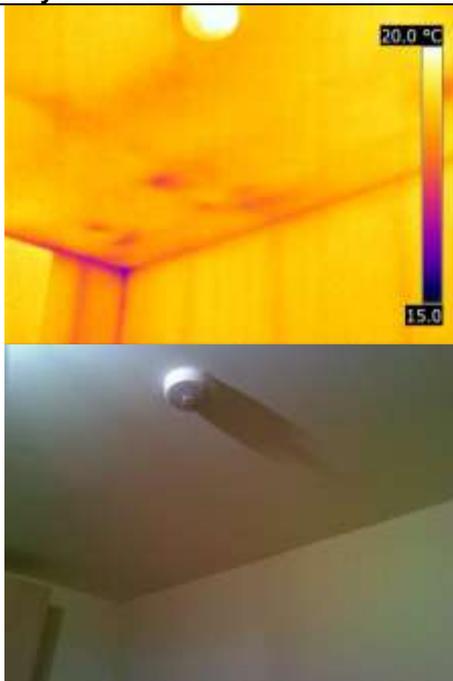
Fig. IR55 – Plot 16 Kitchen

Comments: Image IR55 shows a ceiling image where some minor cross section joist is evidenced by surface heat losses. The image also shows some circular patches perhaps belonging to pipe work or electrical boxes that may have been cancelled and blocked. The corner also shows heat loss often can be thermal bridges where repeated timber elements are placed for structural integrity. Thermogram IR56 shows insulation missing or badly installed leaving gaps between joists and at eaves where it can be difficult to reach. Image IR657 represents pipe work carrying hot water from boiler to radiators. It is clear that a heat source appears to emit heat as it travels to the radiator. This may indicate that the pipe work is un insulated and even if the floor slab is insulated retaining heat within the envelope of the dwelling, it is recommended that pipe work is insulated so that temperature controls (TRV's) provide effective control. In image IR58 the circular area is an air duct from the MVHR system, the system was turned off at the time of the survey. Additional heat loss in edges also shows concern.

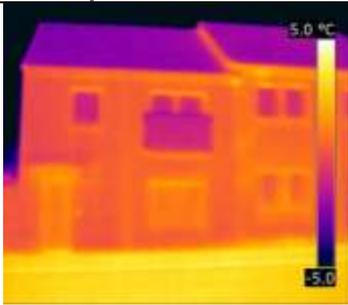
Fig. IR59 – Front elevation plot 18

Comments: Both dwellings present even surface temperatures in all elevations. There is a distinct difference between the walls in plot 17 (control house) and plot 18 (Passivhaus). This can be observed in IR61 where the party wall and the two front walls are against each other. The left hand wall from plot 18 is significantly lower in surface temperature than the right hand wall of plot 17. Detail 10 shows the distinction between them. Plot 17 has a thinner insulated wall compared to plot 18 hence the difference in surface temperature. The contrast is interesting as a whole elevation image in IR60 where both elevations can be seen.

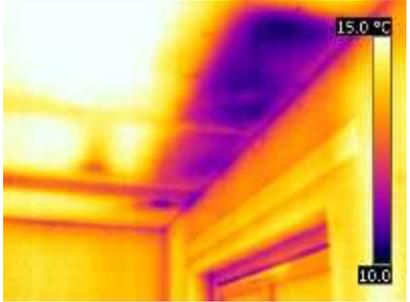
Fig. IR65– Bedroom

Comments: Internal thermograms of the control house show many concerns around the floor and also on the ceilings in the first floor. Image IR65 is of particular concern where a large un insulated section near the eaves of the roof shows heat loss. There are repeated images where ceiling insulation is badly installed or missing completely. Many of the examples above are near junctions between ceilings and wall where detailing can be complicated. IR66 is interesting as it highlights some concern close to the window and adjacent walls. A large heat loss area is located in the wall/floor junction where an element there appears to be creating a thermal bridge.

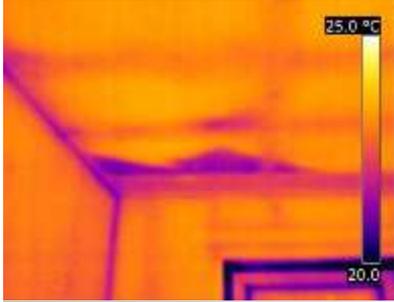
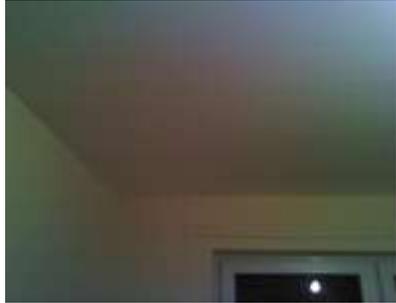
Fig. IR71– Bedroom

Comments: The thermograms belonging to plot 18 show a range of ceiling and floor concerns. IR71 & 72 identifies similar concerns to IR75 & 76 where ceiling heat loss is experienced. There are many colder surface temperatures represented as long patches or concentrated corner patches showing heat loss developing either from missing insulation or air infiltration. Image IR73 shows a floor image where heat loss is experienced on the wall and skirting level. There are two concerns here. The first to do with the skirting area where that junction shows a cold bridge to the floor adventitious ventilation ingress and also the two circular patches on the wall that may be related to rising thermal bridging or missing insulation in that area. Image IR74 shows heat loss close to the switched off radiator where possible pipe work and holes around them are creating a colder surface temperature and heat loss. Often holes around pipe work are left un insulated or sealed as they were after a sequential part of the fitting of insulation.

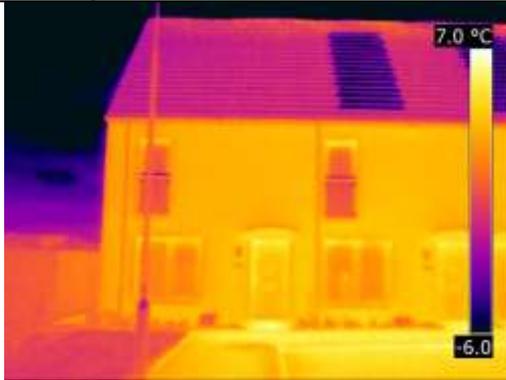
Fig. IR77 – Front elevation plot 21 & 20

Comments: The three dwellings present very similar circumstances despite their different building standards design & construction methodology. All the elevations present even surface temperatures with minimal variations. IR77 shows the front elevation of plot 21 and plot 20. Some heat loss is experienced at the top ridge of the roof in the three dwellings and this may originate from rising heat from heated spaces. Image IR79 shows the 3 dwellings with little external surface temperature differences. Images IR80 & IR81 shows the back elevations with an even distribution of surface temperatures.

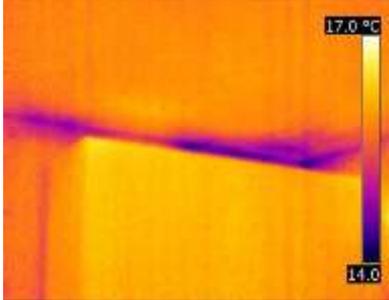
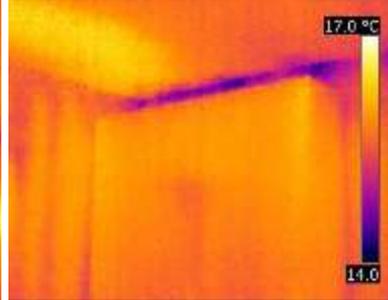
Comments: Internal images show some heat loss in corners and junctions between walls and ceilings. Images IR82 & IR83 show heat loss above kitchen cabinets. These areas are close to roof eaves where insulating in small areas becomes difficult. The attic hatch in image IR84 is acting as a heat escape as lower temperatures are observed around the frame. Repeated strapping of plasterboard shows up in images IR85 & IR86. IR87 shows some heat loss at the back of the WC in the bathroom, this could be caused by services and areas where air infiltration appears.

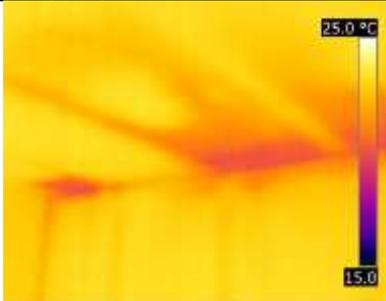
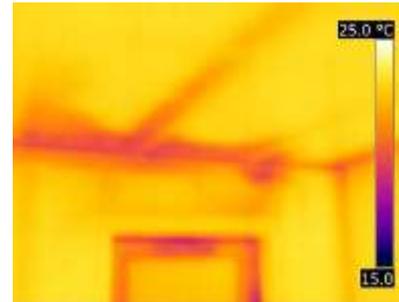
Comments: The thermograms shown above for plot 20 indicate heat loss around wall/ ceiling and around some pipe work entry points as in IR91. These entry points will be for a washing machine that will need to seal around the pipe work in order to contain air tightness. IR90 shows heat loss near the attic hatch with lower surface temperatures experienced around it too. Heat loss at eaves point on the ceiling spans into the room in images IR88 and IR93. Cold air entering under the main front door in IR92.

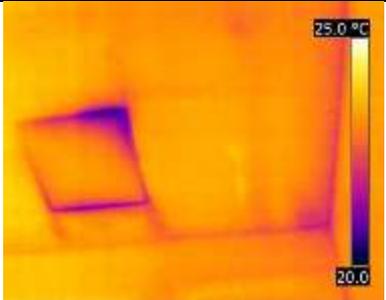
Fig. IR94– Attic hatch - stairs

Comments: The thermograms of this dwelling in plot 21 show some similar concerns observed in plots 19 & 20. A common trend has been observed in the attic hatches where heat loss is experienced around the frame edges, see IR94. There are also areas near the eaves of the roof, particularly on the ceilings, where air infiltration and a lack of insulation indicates lower surface temperatures. Although these temperature differences are between 2 & 3 °C they are considerable in the performance of the dwelling. Image IR98 shows heat loss at skirting level in the kitchens where cabinets are placed.

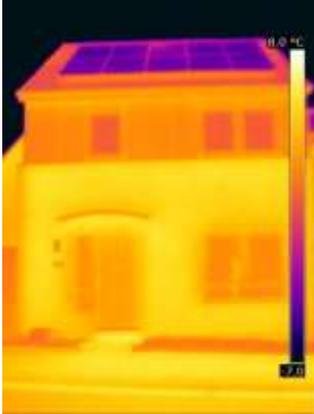
Fig. IR100 – Front elevation plot 23

Comments: External envelope thermograms show some changes between different wall finishes. This could be due to the different emissivity of the materials. Images IR100 and IR101 show the front elevations of the dwellings where the coloured render shows higher surface temperatures in comparison with the Marley Cedral Weatherboarding. Image IR101 also shows higher surface temperatures at the junction between the two plots. This party wall shows increased temperatures and detail 11 indicates how the design drawing specifies mineral wool insulation on both walls and heat conducting below into the cavity. Concerns appear around the party wall cap on front and back elevation junction.

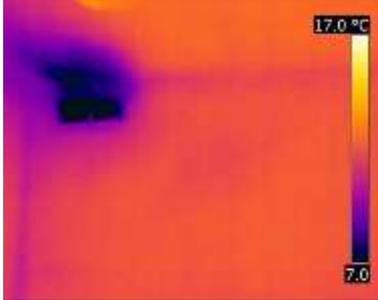
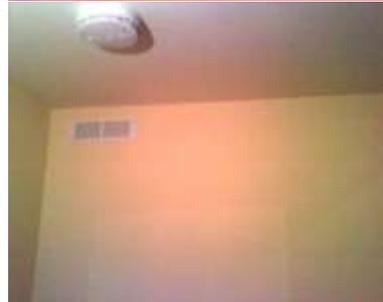
Fig. IR105– Entrance lobby

Comments: Internal thermograms show some concerning images both in ground and first floors. This area has at skirting level heat loss patches where a thermal bridge or air infiltration is occurring. Images IR105 and IR110 show cold air entering the rooms from northerly orientated breathing wall. Image IR107 shows bedroom 2 which is orientated southwards where no cold air is entering the room. Heat loss is appearing in around the perimeter of the sun-pipe where the frame of the element is permitting colder air to enter. Images IR108, IR109 & IR107 show missing or misplaced insulation on the ceiling level. These are close to the junction between wall/ceiling but also across the ceiling into the room and also in junctions between ceiling and vertical duct work (IR109).

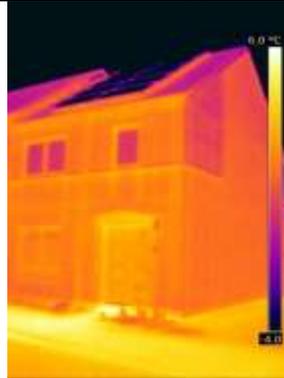
Fig. IR111 – Side/ front elevation plot 24

Comments: The thermograms of these dwellings show some concerns in various elevations. The dwellings have a dual wall finish. The upper front elevation rooms have a weatherboard as a finish and the rest of the rooms have a proprietary render. They both hold a ventilated void behind the finish. Images IR111, IR112 & IR113 show vertical lines with higher surface temperatures. Detail 13 shows the wall timber structure covered internally by insulation which would limit thermal bridging. The weatherboard and render requires a frame system which would be the reason for these cross section higher temperature lines. Detail 12 confirms that insulation in the party wall cavity between the two dwellings benefits by limiting heat loss at the wall junction.

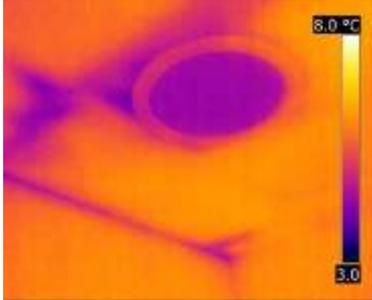
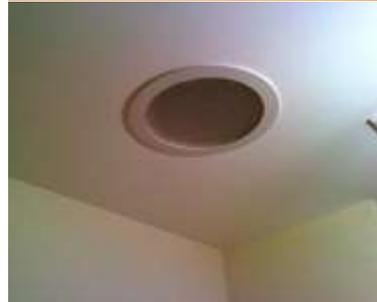
Fig. IR116– Sun pipe top of stairs

Comments: Internally, plot 25 presents some concerns around sun pipes and ceilings close to the roof eaves. Image IR116 shows the sun pipe located at the top landing of the stair case. The detailing around it has highlighted lack of insulation or insulation that is placed incorrectly. Thermogram IR117 shows heat loss appearing close to the wall/ ceiling junction where joists may be creating a thermal bridge and additional colder surface temperatures above the window at the eaves detail. IR119 and IR120 show a similar scenario with lack of or badly placed insulation at the eaves junction with the wall. Thermogram IR121 shows some heat loss at the skirting board level in the ground floor bathroom but what is more concerning is the vertical heat loss appearing on the external wall from a timber structural element or pipe work going upwards to the first floor. Image IR118 shows heat loss at the door edge in the kitchen. This is a common heat loss path where draught proofing is not effective enough.

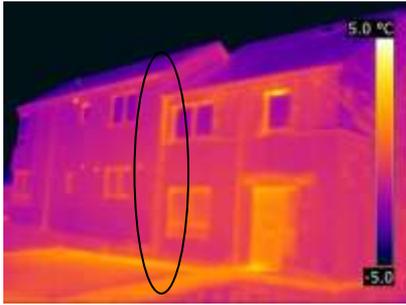
Fig. IR122 – Front elevation plots 32 & 33

Comments: The external images show consistent surface temperatures across the envelope with the exception of the party wall junction and front elevation patches with heat loss near the eaves of the roof in plot 33. Image IR122 shows how some heat loss appears vertically where the party wall is positioned in between the two plots. Details of this wall were not available but detail 15 shows the how concrete core wraps round the wall and connects with both plots. This also applies to the insulation of the BECO block. Thermogram IR124 shows some heat loss patches on the weatherboarding in the front elevation of the first floor. These patches appear to be sequential. Detail 14 shows the bolts that are drilled into the concrete.

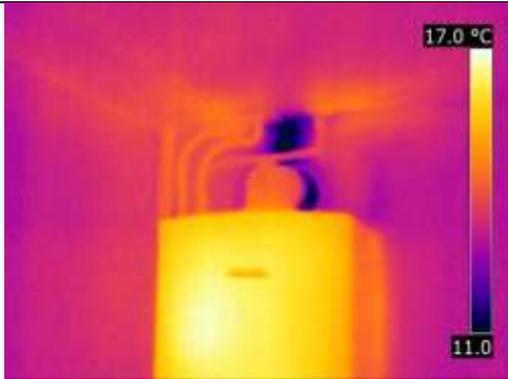
Fig. IR128 – Plot 33 Boiler pipe work in Kitchen

Comments: Internal thermograms of plot 33 show some concerns especially on the ceilings. IR128 shows missing insulation above the flue, which had a larger hole for positioning and was later blocked up. Image IR129 shows heat loss at ceiling level where loft insulation has not reached those areas sufficiently or possibly air infiltration is appearing. IR130 shows a similar example of this. Image IR131 shows the similar eaves ceiling/wall junction but with a greater impact on the corner of the wall where heat loss is experienced beyond the line of the eaves and across a joist or other element creating thermal bridging.
