Housing Innovation Showcase 2012 Building Performance Evaluation Phase 1 – Part 1

HOUSING INNOVATION SHOWCASE 2012
affordable ^ sustainable ^ construction

kingdom
housing association

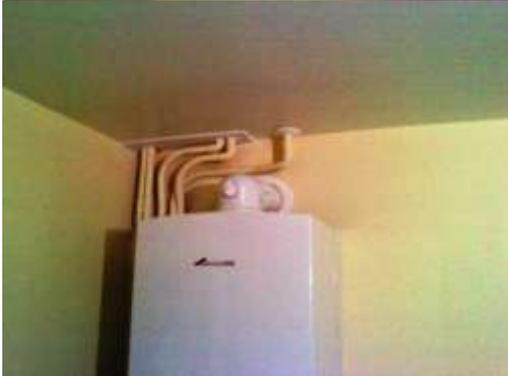
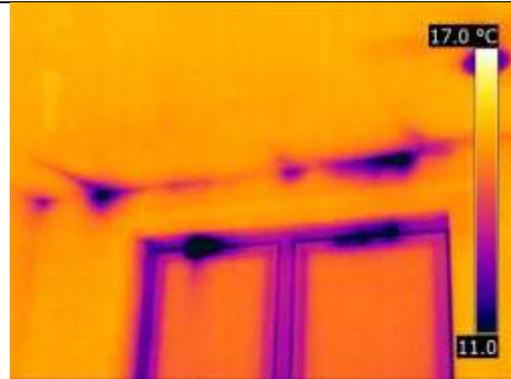
Fig. IR129– Plot 33 Bedroom 2

Comments: Internal thermograms of plot 33 show some concerns especially on the ceilings. IR128 shows missing insulation above the flue, which had a larger hole for positioning and was later blocked up. Image IR129 shows heat loss at ceiling level where loft insulation has not reached those areas sufficiently or possibly air infiltration is appearing. IR130 shows a similar example of this. Image IR131 shows the similar eaves ceiling/wall junction but with a greater impact on the corner of the wall where heat loss is experienced beyond the line of the eaves and across a joist or other element creating thermal bridging.
